Original Article

Microstructural evolution and microhardness in a low carbon steel processed by high-pressure torsion[☆]

Diana Maritza Marulanda Cardona^{a,*}, Jittrapun Wongsan-Ngam^b, Terence G. Langdon^c

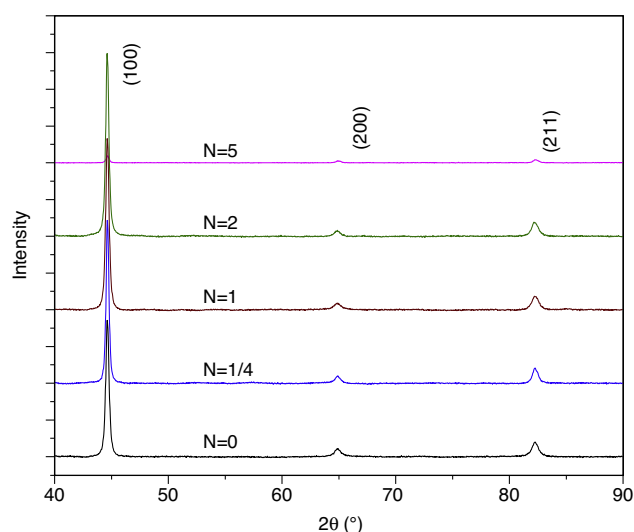
Fig. 1 shows the X-ray diffraction patterns of the samples processed to different numbers of turns. Only the ferrite phase in orientations (1 1 0), (2 0 0) and (2 1 1) is observed according to the JCPDS 00-006-0696 database. Diffraction peaks of pearlite

Fig. 1 – X-ray diffraction patterns for the samples processed through different numbers of turns.

were not present due to its low volume fraction in this steel. It is readily apparent that no phase transformation occurs after the HPT process. However, there is a change in the peak intensities after five turns that indicates the occurrence of microstructural changes due to the formation of nanostructures and the dissolution of the pearlite lamella in the steel [8,9]. On the other hand, the full width at half maximum of the peaks does not show a significant variation and this is probably because the patterns were taken at the centers of the disks in the low deformation zone.
