# An experimental investigation into the influence of the damage openings on ship response

In this paper an experimental campaign is carried out on a passenger ferry hull, to show the effects of the water dynamics across damage openings on ship motions. Novel aspects of this research include the study of the effects of the damage position on the ship roll response. The study is carried out for still water and for beam regular waves at zero speed.

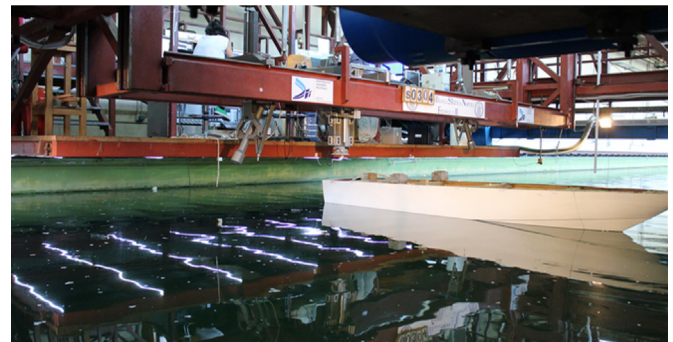
Fig. 1. Towing tank and ship model during the test.

The roll response of the ship model was investigated in intact and damage conditions in still water and regular beam waves. During the tests the motion responses of the model were measured by using QUALISYS motion capture system. This system is capable to gauge the coordinates of infra-red reflective markers by means of three suitable cameras. Four infra-red reflectors were rigidly placed on the deck of the hull model while the cameras were positioned on the towing carriage near the vessel. The six-degree-of-freedom model motions were calculated and output in real time. In carrying out the tests, the towing carriage was moved almost at 2/3 of the towing tank length and the model was placed transversely beneath it (see Fig. 1). This was done in order to avoid wave reflection problems.

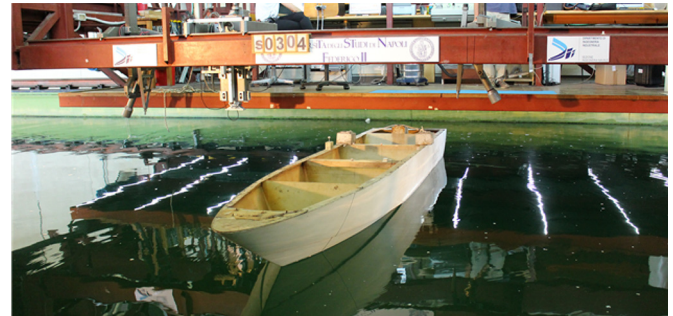
Fig. 2. Model arrangement during the test in beam waves.

The wave elevation was measured by using two ultrasonic probes (previously compared with capacitive probes). The first one was located at 2.3 m from the model side (in the  $y$ -direction), the other one at 2.5 m from the ship bow (in the  $x$ -direction). The first probe was used to monitor and record the free-surface elevation caused by the waves radiated by the model in the  $y$ -directions (roll decay test); the other probe, instead, monitored and recorded the

waves generated by the wave maker with no vessel perturbation (roll in wave tests) (see Fig. 2). QUALISYS sampling frequency was set to 72 Hz; wave elevation, measured by the probes, was obtained with a sampling frequency of 500 Hz.
