# ELBOW ARTHRODESIS IN A BALD EAGLE (*HALIAEETUS LEUCOCEPHALUS*)

## Abstract

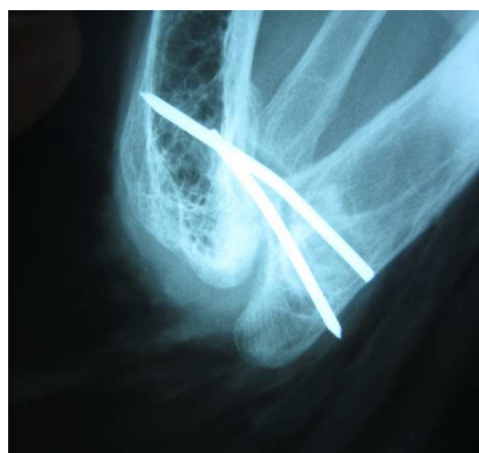
**FIGURE 1.** A dorsoventral radiograph of the right elbow of an adult female bald eagle (*Haliaeetus leucocephalus*). Arthrodesis of the elbow was attempted by debriding the articular cartilage of the ulna and humerus to subchondral bone. A total of 2 intramedullary pins of 2.0 mm were placed in crossing fashion to immobilize the joint. This configuration eventually failed.

ulnaris muscle tendons were transected 4 mm from their origins on the dorsal epicondyle of the humerus. The joint capsule was incised to expose the articular surfaces of the humerus and ulna. The articular cartilage was debrided to bleeding subchondral bone using a round dental burr. The area was continuously flushed with sterile saline to cool the tissues and remove cartilage debris. The ulna and humerus were apposed with Kerr bone forceps and 2 nonthreaded intramedullary pins of 2.0 mm were placed, one from the distal caudal surface of humerus into the proximal ulna and the other from the proximal ulna into the humerus in crossing fashion (Fig. 1). The joint capsule was closed with 3-0 polyglactone (Securocryl; Securos Surgical, Fiskdale, MA USA) in a simple continuous pattern. The tendons were reattached using 3-0 polydioxanone (PDS\*II; Ethicon LLC, Guaynabo, Puerto Rico) in a Bunnell-Meyer pattern followed by skin closure using 3-0 nylon (Ethicon LLC, Guaynabo, Puerto Rico) in a Ford interlocking pattern. Intramedullary pins (2.8 mm) were driven perpendicular to the bone into the dorsal humerus about 10 and 20 cm from the shoulder and additional pins were placed into the dorsal ulna at similar distance from the carpus and adjacent to the humeral pins. A total of 2 type I external skeletal fixators were applied to adjacent pins from humerus to ulna by injecting an acrylic (Technovit, Jorgenson Laboratories, Inc., Loveland, CO USA) into 0.5 in diameter Penrose drain tubing, stabilizing the elbow in flexion. Following surgery the bird was placed on meloxicam
