NOVEL SHELL WOUND CARE IN THE AQUATIC TURTLE

Abstract

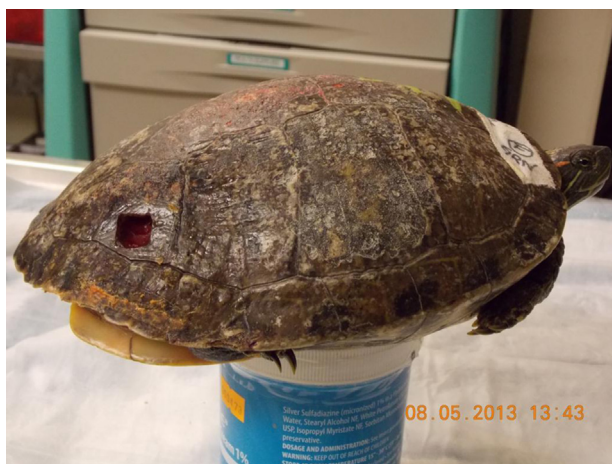
FIGURE 1. Surgically created full-thickness shell wound in a study subject.

In total, 14 red-eared slider turtles (*Trachemys scripta elegans*) were used to develop a shell wound healing model at the Boren Veterinary Teaching Hospital of Oklahoma State University from August 2013 to January 2014. After each turtle was premedicated with tramadol (Roadrunner Pharmacy, Phoenix, AZ USA) 10 mg/kg subcutaneous, the turtles were heavily sedated with injections of midazolam (West-Ward, Eatontown, NJ USA) 1.0 mg/kg subcutaneously, and dexmedetomidine (Dexdormitor; Pfizer Animal Health, New York, NY USA) 0.1 mg/kg subcutaneously. This level of sedation and pain control allowed investigators to surgically create a full-thickness shell lesion using a high-speed dental burr (iM3 Elite iM3 Inc., Vancouver, WA USA). The lesion was 1 × 1 cm² and located on the caudolateral aspect of the carapace (pleural scute), exposing underlying musculature (Fig. 1). Following the procedure, a 2% lidocaine (Hospira Inc., Lake Forest, IL USA) splash block (0.1 mL, topically) was performed, and the sedation was reversed with atipamezole (Antisedan; Pfizer Animal Health, New York, NY USA) 0.1 mg/kg intramuscularly; tramadol 10 mg/kg subcutaneously every 12 hours for 36 hours was also administered. Subjects were given ceftazidime (Sagent, Schaumburg, IL USA) 20 mg/kg subcutaneously every 3 days for 4 total treatments. A light, nonocclusive bandage was placed postprocedure, and the resultant open shell wound was allowed to heal via second intention.
