# Innovative solutions please, as long as they have been proved elsewhere: The case of a polished lime-pozzolan concrete floor<sup>☆</sup>

E.R. Grist<sup>a,b,\*</sup>, K.A. Paine<sup>b</sup>, A. Heath<sup>b</sup>, J. Norman<sup>c</sup>, H. Pinder<sup>a</sup>

<sup>a</sup> Ramboll, 40 Queen Square, Bristol BS1 4QP, UK

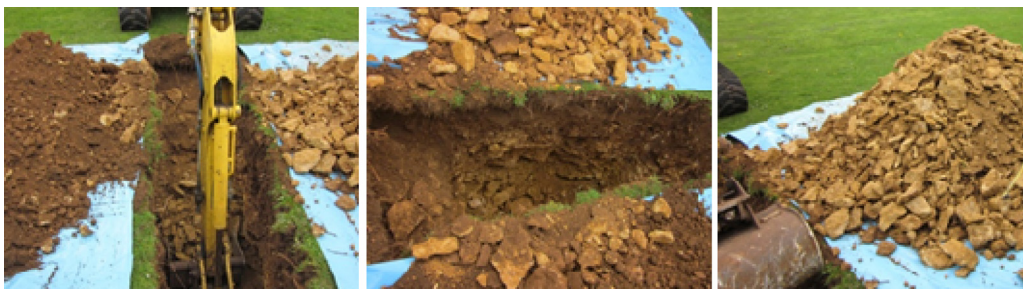
Fig. 1. Frost-shattered oolitic limestone (FSOL) unearthed during the site investigation.

The project Site Investigation (SI) was conducted by a geotechnical engineer in April 2011. The structural engineer was present during the excavation to take a sample of the soil, in order to test whether site material was suitable for construction of a rammed earth wall. During the excavation of a number of trial pits, within the footprint of the new building, a 300–700 mm thick band of frost-shattered material was encountered from approximately 0.2 metres below the surface (Fig. 1). In the trial pit log this material was described as *'loose becoming medium dense beige brown to mid-brown silty sandy GRAVEL and COBBLES of sub-angular oolitic limestone'* (SI report, April 2011).

Recognising that this naturally occurring site material might also potentially be suitable for use within the fabric of the new building, a sample of this frost-shattered oolitic limestone (FSOL), passed through a 50 mm screen, was also bagged for testing in the laboratory. Specifically preliminary testing was undertaken to establish if this site-won material might be suitable as aggregate for a lime-pozzolan concrete.
