# Residual properties of square FRP composite tubes subjected to repeated axial impact

Ernesto Guades, Thiru Aravinthan \*

Centre of Excellence in Engineered Fibre Composites (CEEFC), Faculty of Engineering and Surveying, University of Southern Queensland, Toowoomba, Queensland 4350, Australia

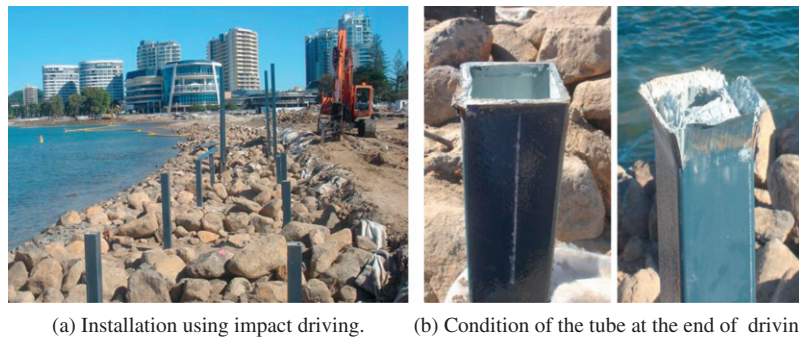
Fig. 1. Pultruded composite tubes used in shoring up boardwalks, Tweed Heads, New South Wales. (Courtesy from Wagners CFT, Queensland, Australia).
