### Construction and Building Materials 106 (2016) 133-139

## An extensive laboratory investigation of the use of bio-oil modified bitumen in road construction

Several roads in Iceland with bio-oil modified surface dressings exhibited severe distresses such as bleeding, binder drain down, and eventually as surface dressing sticking to tires. Samples from six road sections were evaluated in the laboratory to determine the causes of the failure. Binders with and without bio-oil, rapeseed oil and fish oil, were evaluated through a comprehensive rheological and chemical characterization. Both oils, exhibited solubility issues with the bitumen; consequently, the oils covered the aggregates, preventing bonding between binder and stones. It appears that fish oil worked a little better than rapeseed oil for binder modification.

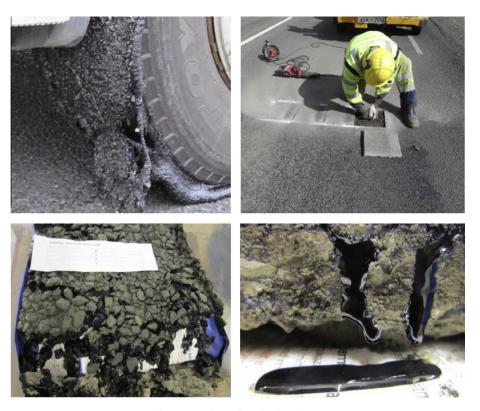
Fig. 1. Extensive surface dressing damage.

pores in the surface layer, sticking to the tires of vehicles passing over the area (Fig. 1). Preliminary studies indicated that the worst bleeding was detected in the old rapeseed oil modified bitumen pavement sections; however, sections with ethyl ester from fish oil were also affected.
