## A new joint to assemble light structures of bamboo slats

Laura Villegas, Richard Morán, José Jaime García\*

Escuela de Ingeniería Civil y Geomática, Universidad del Valle, Cali, Colombia

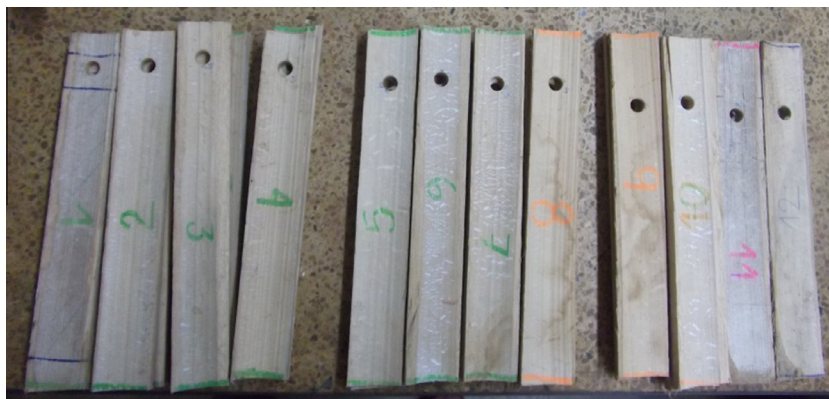
Fig. 1. GA slats that can be easily obtained from culms.

GA culms can be easily split along longitudinal planes to produce slats with standard widths (Fig. 1). Previous studies with other species of bamboo and GA [3–4,18] have shown that the material is functionally graded as the fiber density is higher toward the external surface of the culm while the inner part is relatively
