Field performance evaluations of partial-depth repairs

Dar-Hao Chen^{a,b,*}, Huang-Hsiung Lin^c, Renjuan Sun^d

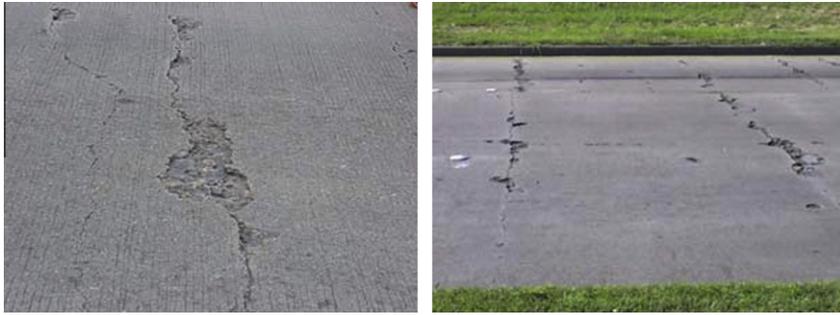
Fig. 1. Spalls on different highways.

Spalls have been observed on various highways in Texas, as shown in Fig. 1. Spalls tend to propagate under repeated thermal stresses and/or traffic loadings. They usually start on the pavement surface and lead to the eventual dislodging of concrete. Spalls reduce pavement serviceability, and if left unrepaired, can become hazardous to the traveling public. Partial-depth repair (PDR) is a common choice for rehabilitating localized spalls and cracks of depth less than one-third to one-half of a concrete slab [1]. Compared to full-depth repair (FDR), PDR offers advantages such as less construction cost and time, shorter lane closure and less damage to the existing pavement. The 1998 ACPA manual indicates that spalls and cracks can be corrected by PDR, as long as they are well sealed. It is believed that hairline and narrow cracks still maintain aggregate interlock and can effectively transfer loads. Thus, PDR can be an effective repair method for spalls and cracks, improving functional performance of pavement and extending pavement life. For jointed concrete pavements (JCP) or continuously reinforced

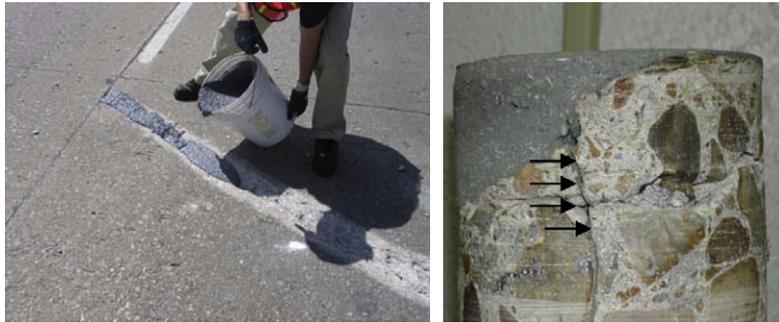
Fig. 2. Partial-depth repair (PDR) and the ability of Material A to bridge the transverse cracks in the concrete.
