Cyclic behavior of combined and confined masonry walls

Arturo Tena-Colunga*, Artemio Juárez-Ángeles, Víctor H. Salinas-Vallejo

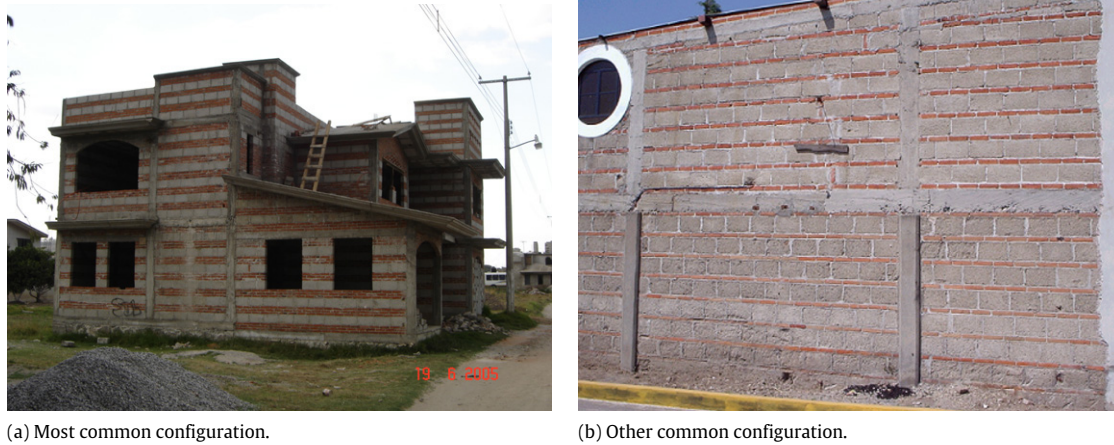
Fig. 1. Combined and confined masonry construction currently built in Mexico.

are alternated with courses of clay bricks (more expensive), as depicted in Fig. 1. Important savings in cost and execution time are obtained with this type of masonry construction, besides having an aesthetic appearance when two or more courses of brick are alternated with one or two courses of concrete blocks, as illustrated, for example, in Fig. 1a.

This modern version of combined and confined masonry has been being used since early 1990s. Different arrangements to combine and alternate brick courses with block courses have been used [15–17], but the one that it is more commonly used is the one depicted in Fig. 1a, where three courses of clay bricks alternate with a course of concrete blocks.

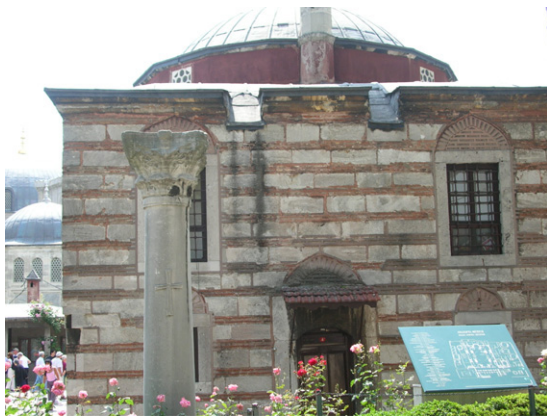
Fig. 2. Old combined masonry construction in Istanbul, Turkey.

This modality of construction has historical background worldwide, for example, in some ancient buildings and walls fences at Istanbul, Turkey (Fig. 2), in old cities of Europe (Fig. 3) and in few buildings of the XVII or XVIII century in Mexico (Fig. 4), where natural stones were alternated with fired bricks. However, the more recent version of confined and combined masonry became popular in recent times by the initiative of the inhabitants of the Mexican states of Puebla, Tlaxcala and Oaxaca. They tried to solve empirically with this modality the cracking problem observed in walls made with concrete blocks due to differential settlements. As a matter of fact, their idea of alternating courses of bricks with concrete blocks was successful to solve that problem.

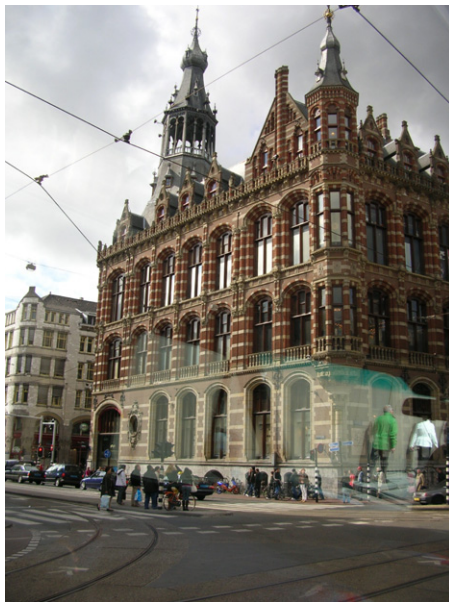
Fig. 3. Old combined masonry building in Amsterdam, Netherlands.
