Staged Reconstruction of a Multiplane Post-traumatic Deformity: A Case Report

Damaging effects of joint function can occur after fractures of the lower extremity that have healed with an angular malunion. Surgical techniques have been described to restore the normal mechanics and establish a plantigrade foot, including osteotomy and fusion. In the present report, we describe a unique case of a 17-year-old male who had initially experienced a severe injury to his left lower extremity and foot when he had been run over by a jeep. Originally, a Lisfranc injury with navicular and cuboid fractures were surgically corrected. He had also sustained an extra-articular distal tibial and fibular fracture, which had been conservatively managed. Seven months after the initial incident, he underwent 3-staged reconstructive surgery because of a malaligned valgus ankle with fibular malunion and a painful collapsing pes planovalgus deformity. A supra-malleolar tibial osteotomy with fibular lengthening was first performed, followed by triple arthrodesis with removal of hardware and then syndesmosis repair. The present report discusses our clinical evaluation and surgical technique for this multipla

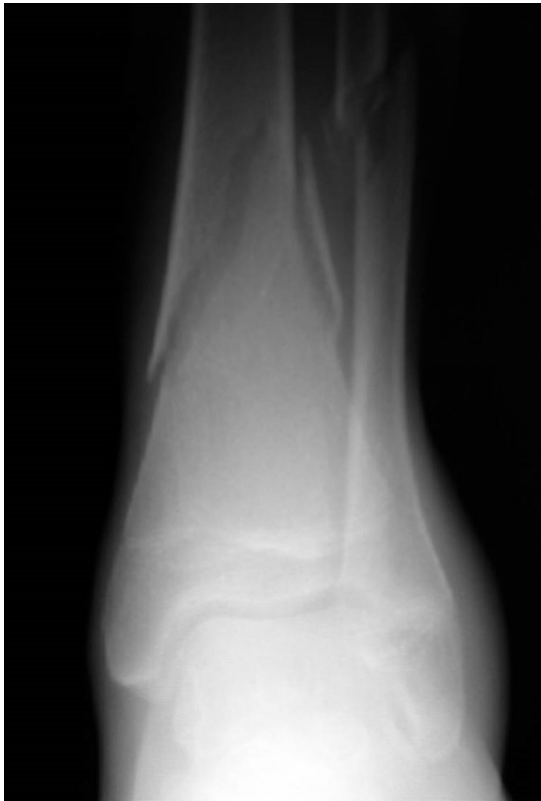
Fig. 1. Anterior posterior ankle view of initial injury consisting of a distal tibial extra-articular fracture and fibular fracture.

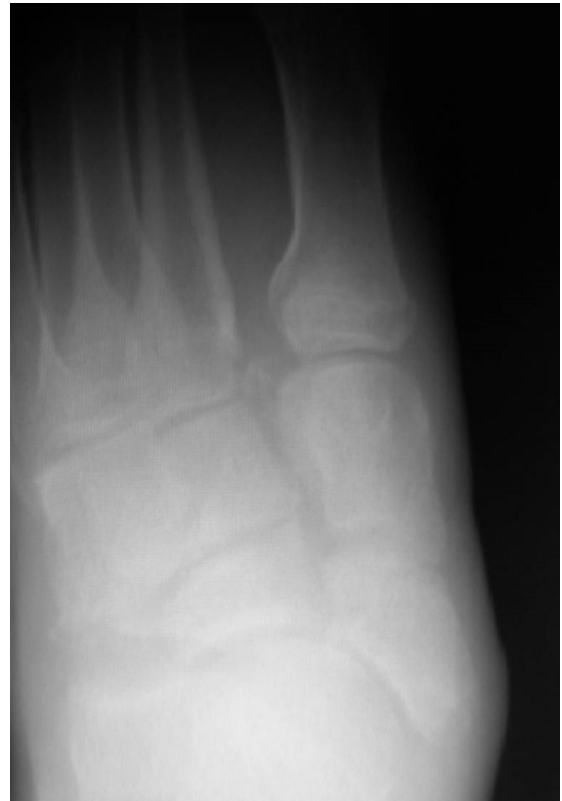
Fig. 3. Dorsoplantar foot view of initial foot injury consisting of fractures of the cuboid and navicular and Lisfranc dislocation.

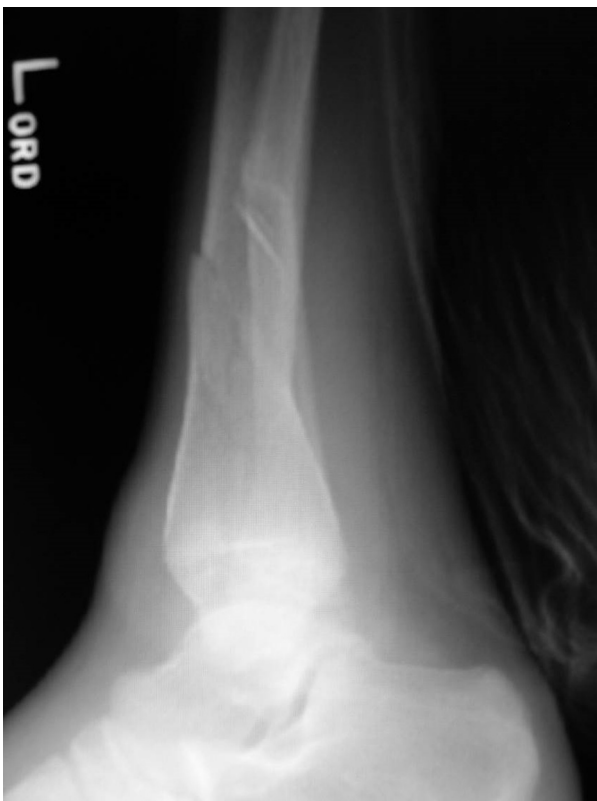
Fig. 2. Lateral ankle view showing initial injury consisting of a distal tibial extra-articular fracture and fibular fracture.
