F. Hoffmann et al.

CASE REPORT / SPECIAL ISSUE

Unusual injury mechanism of a tibial plateau fracture in relation with a knee brace in handball – A case study

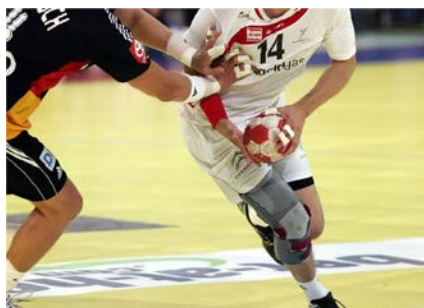
Figure 1
Playing scene of an international game between Germany and Austria. The picture shows an Austrian player wearing a hinged, reinforced knee brace.

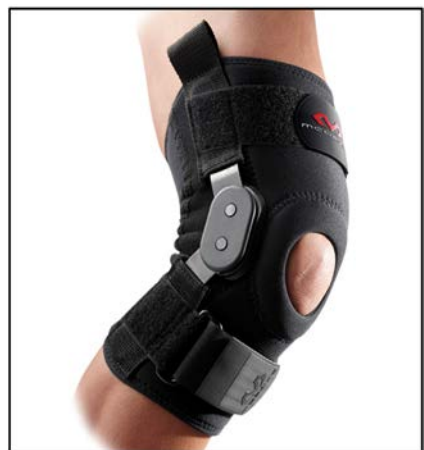
Figure 2
Type of brace worn by the defensive player. ©McDavid PS II.

A 47-yo male former semi-professional handball player presented at the emergency unit after he was injured during an official handball game. While he was about to jump off his left foot to shoot, he hit his right lateral knee, which was in a slightly bend position, against the hinges of the opponent's knee brace (Fig. 2). Clinical examination showed a non-weight bearing patient using crutches, a significant, visible and palpable effusion of the right knee. The patient's range of motion was reduced with full extension and a maximum flexion of 80° with tenderness on the lateral tibial plateau. Radiographic imaging consisted of X-ray and

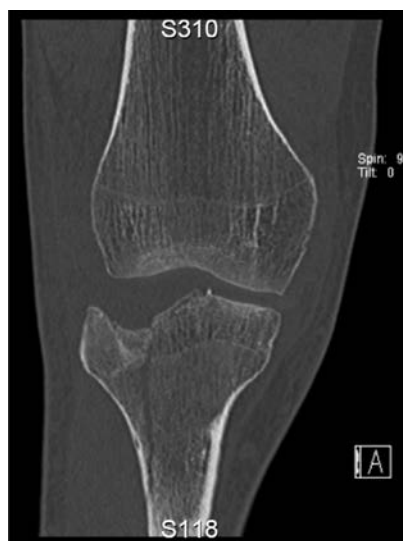
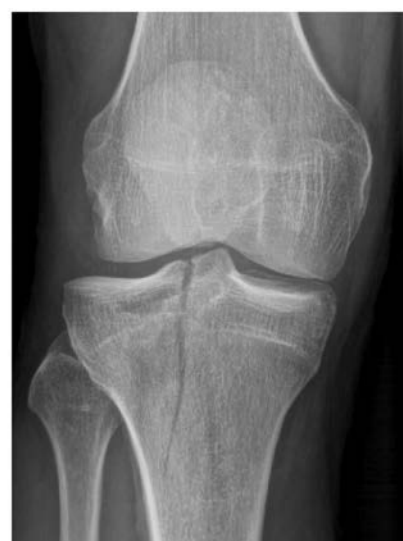
CT-scan to evaluate the bony structures, as well as an MRI to assess the soft tissue damage. Radiographs showed a longitudinal fracture of the lateral tibial plateau and the CT-scan revealed a Schatzker type II fracture with a 6 mm deep impaction of the articular surface on the lateral tibial plateau (Fig. 3). The MRI images reveal an abundant effusion, a bone bruise of the lateral tibia, a sprain of the anterior cruciate ligament, a non displaced bony avulsion of the posterior cruciate ligament, the fracture line and a lateral collateral ligament injury. The final diagnosis was a fracture

Figure 3
Coronal CT scan image and standard a.p. radiograph showing a Schatzker type II tibial plateau fracture.

of the lateral tibial plateau with impaction (Schatzker type II), a subtotal bony avulsion of the posterior cruciate ligament and an elongation of the lateral collateral ligament and the anterior cruciate ligament (ACL).

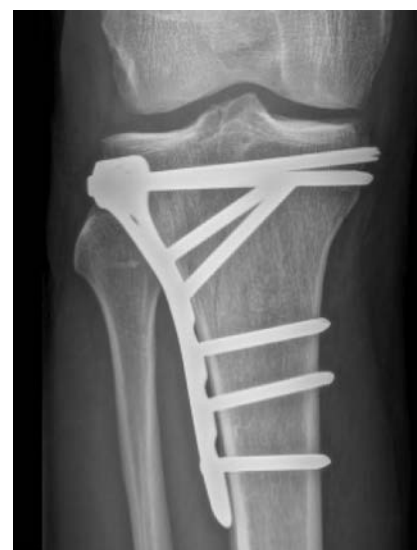
Figure 4
Postoperative radiograph after arthroscopy-assisted open reduction and internal fixation of the tibial plateau fracture.

Treatment consisted of an arthroscopy, with releveling of the tibial articular surface, and an open reduction with internal fixation of the longitudinal fracture using a Synthes® LCP proximal Tibia plate system (Fig. 4). The posterior cruciate ligament showed good intra-operative stability and was not addressed.
