HBRC Journal

Study of the behavior of corroded steel bar and convenient method of repairing

Abstract This paper presents an experimental investigation into the residual strength and mechanical properties of corroded reinforcing bare bars. An attempt has been made to describe firstly the impressed current technique which is commonly used for accelerating reinforcement corrosion. The study compared between two methods of repairing the corroded steel bar, the first one which mostly used by painting the half surface area of corroded bar; and the another one by coating the full surface area of corroded bar. The experimental results show that, the corrosion process alters the external surface of steel bar due to pitting, the residual cross-section of the corroded bar is no longer round and varies considerably along its circumference and its length so the residual diameter is better defined by loss of weight. The rate of corrosion has been calculated by two terms, the term of mass loss rate (MR) and the term of penetration rate (CR). The mass loss rate decreased for fully coated bars by 1.7–2 times than half coated bars showing the importance of fully coating bars in corrosion repair. F

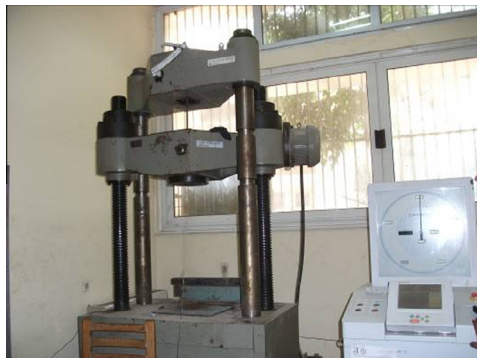
Fig. 1 Universal testing machine.

The second group (Group B) consists of 12 reinforcement steel specimens with diameters 10 mm, 12 mm with length 500 mm and 16 mm with length 600 mm. The steel bars were corroded firstly to 10% and 30% corrosion degree; each corrosion degree has two samples of each diameter. Then the corroded bars were cleaned of rust and coated with commercial coating material (Epozinc) for repairing the corroded steel bars. For the same diameter, one of the specimens is fully coated and the other one is partially coated with the same coating material via painting the half surface area of the steel bar for the same degree of corrosion. After that the fully and partially coated bars are exposed again for the same corrosion time. The uniaxial tension tests of the reinforcement specimens were performed using a Universal Testing Machine (Fig. 1). The load cell, electrical strain gauges glued to the bars were connected to the Data Acquisition System to collect readings every five second by means of a computer program that runs under the "PCD-30A" software (Fig. 2). The technique of accelerated and simulated corrosion was employed into groups.

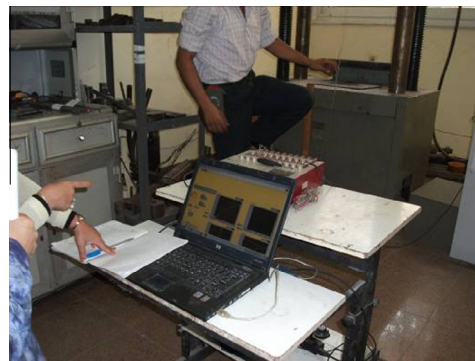
Fig. 2 The data logger.
