Endovascular Repair of Concomitant Vertebral Artery and Subclavian Artery Iatrogenic Perforations

Joseph W. Herrmann, Randall W. Franz, and Kaushal J. Shah, Columbus, Ohio

Ann Vasc Surg 2015; 29: 838.e17–838.e20
<http://dx.doi.org/10.1016/j.avsg.2014.11.015>

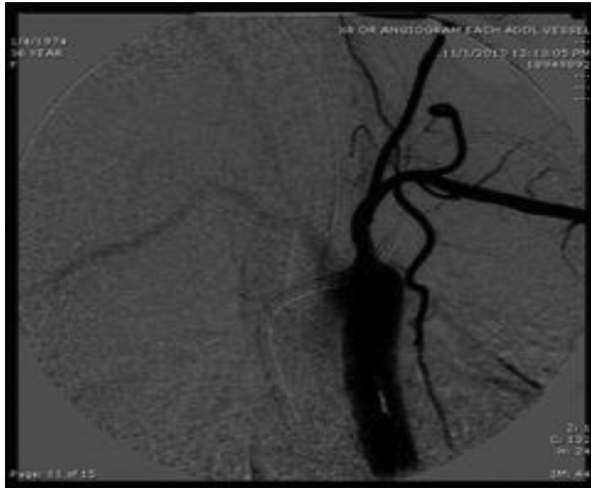
After initial evaluation of the patient, a retrograde hand injection through the left-sided sheath was performed (Fig. 1). This injection demonstrated good perfusion of contrast through the left subclavian artery and into the aortic arch. At this point, it appeared that the catheter had been inadvertently placed into the left

Fig. 1. Hand injection through sheath showing perfusion into the left subclavian artery.

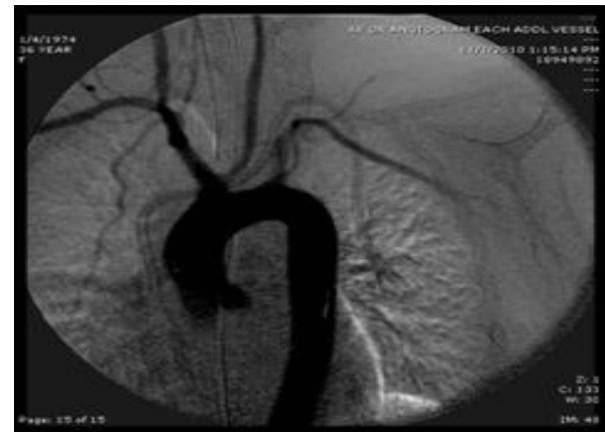
subclavian artery. The sheath was left in place, right common femoral artery percutaneous access was then obtained under fluoroscopic guidance, and a 4F sheath was placed. A pigtail catheter was positioned in the aortic arch, and an arch aortogram was performed (Fig. 2). Good perfusion was found through the aortic arch and into the great vessels. The patient was noted to have bovine anatomy with the left common carotid artery arising from the right innominate artery. The right vertebral artery was patent and 3 mm in size. The sheath was noted to be in the left subclavian artery at the level of the left vertebral artery takeoff. The left vertebral artery was not visualized. This finding was not in concordance with her preoperative angiogram to evaluate the LIMA, which demonstrated a large patent left vertebral artery. This finding raised concern for concomitant left vertebral artery injury.

Fig. 2. Aortogram showing bovine anatomy, defect noted in the left subclavian artery due to the sheath, and absence of the left vertebral artery.

Now that the extent of the injury had been evaluated further, we proceeded with the idea repairing the lesions with stent grafts. An 8F long sheath was placed and positioned in the left subclavian artery. The left subclavian vein catheter was pulled back partially, and a hand-injected retrograde angiogram was repeated through the catheter, showing perfusion through the left vertebral artery, confirming perforation of the catheter into the left vertebral artery. Selective cannulation of the left and right vertebral arteries was then performed. Brisk runoff was demonstrated bilaterally, into the basilar artery without note of intimal defects or thrombus. Wire access of the left vertebral artery was then obtained, and a 5×25 mm² self-expanding Viabahn (Gore, Newark, DE) stent graft was deployed in the left vertebral artery under fluoroscopic guidance, covering the perforation site. As the stent graft was deployed, the catheter was simultaneously withdrawn from the vertebral artery under fluoroscopic guidance. In a similar fashion, a 7×25 mm² self-expanding Viabahn (Gore, Newark, DE) stent graft was deployed in the left subclavian artery.

The left subclavian stent graft was placed to cover the perforation in a position proximal to the left vertebral artery and the LIMA. Care was taken to assure the patency of the LIMA, so that it could be used for the originally planned LIMA to LAD coronary bypass.
