Load-carrying capacity of locally corroded steel plate girder ends using artificial neural network

Sajjad Tohidi, Yasser Sharifi*

Department of Civil Engineering, Vali-e-Asr University of Rafsanjan, Iran

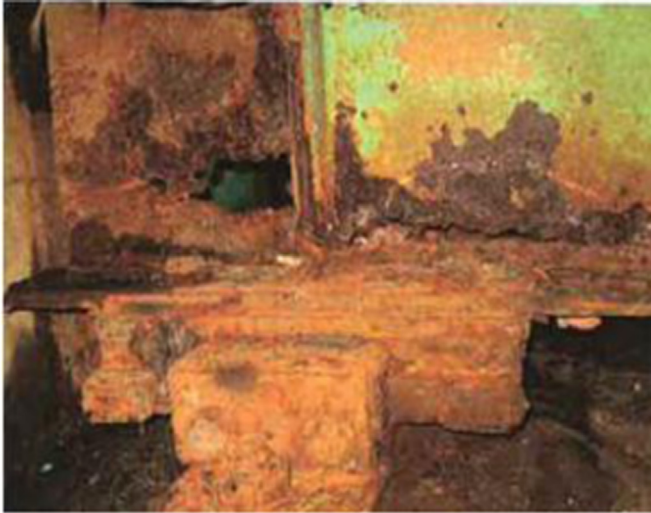
Fig. 1. An example of local corrosions in end panels [15].

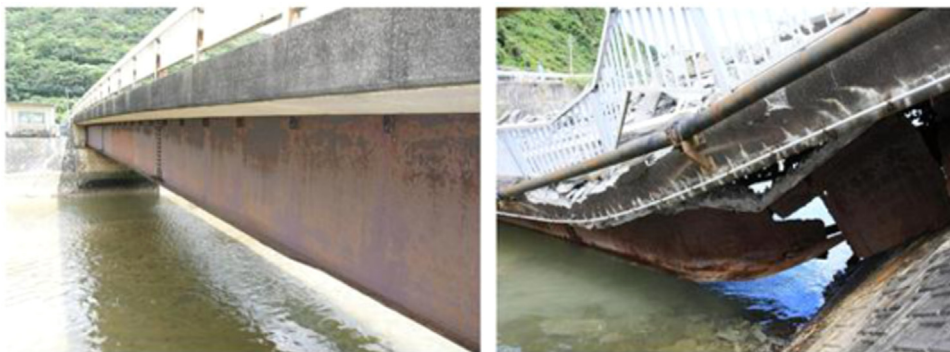
Fig. 2. Collapsed plate girder bridge reported by Ahn et al. [6].

several points these preservations such as painting break down and the corrosive environment attack to the pure steel and make it damaged [11]. For example, Fig. 1 shows a plate girder bridge that collapsed owing to severe corrosion [6]. Therefore, assessment the residual strength of these structures is an important issue to keep them in a reliable and safe utilization.
