# Restoration of Fluorosis Stained Teeth: A Case Study

• Fluorosis • Golden proportion • Teeth-whitening • Porcelain veneer restorations

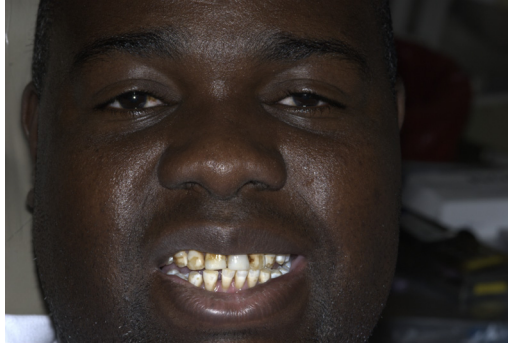
**Fig. 1.** Full-face view of severe anterior fluorosis case.

The patient was a 35-year-old African American man originally from Senegal, Africa who presented to New York University College of Dentistry with the chief complaint of discoloration of his anterior teeth and the desire to have white natural-looking and straight teeth (**Figs. 1** and **2**). His chief complaint: “I need cosmetic work.”

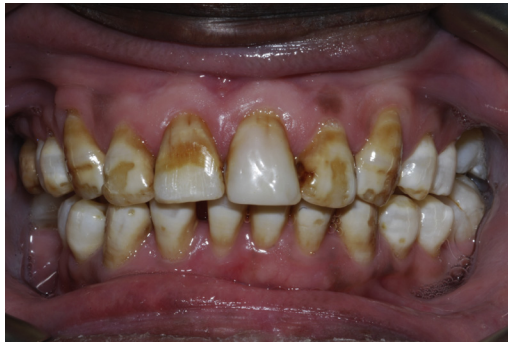
**Fig. 2.** Retracted view of severe anterior fluorosis case.
