## Original article

# Evaluation of the effect of surface preparation using phosphoric acid and luting cement on the flexural strength of porcelain laminate veneering material

**Methods:** 210 porcelain discs of 15 mm diameter and 0.9 mm thickness were prepared. These study samples were divided into seven groups of thirty samples each. Surfaces of the first (control) and the second group of samples were not prepared. The surfaces of other five groups were prepared with different surface treatments. Further all the groups of specimens were coated with a layer of resin luting cement. Flexural strength of each specimen was determined using universal testing machine and the results were compared. **Results:** The combination surface treatment using alumina surface abrasion followed by etching with phosphoric acid provided the highest flexural strength with the mean flexural strength of 101.11 MPa, followed by alumina surface abrasion (95.41 MPa), and phosphoric acid surface etching (81.68 MPa).

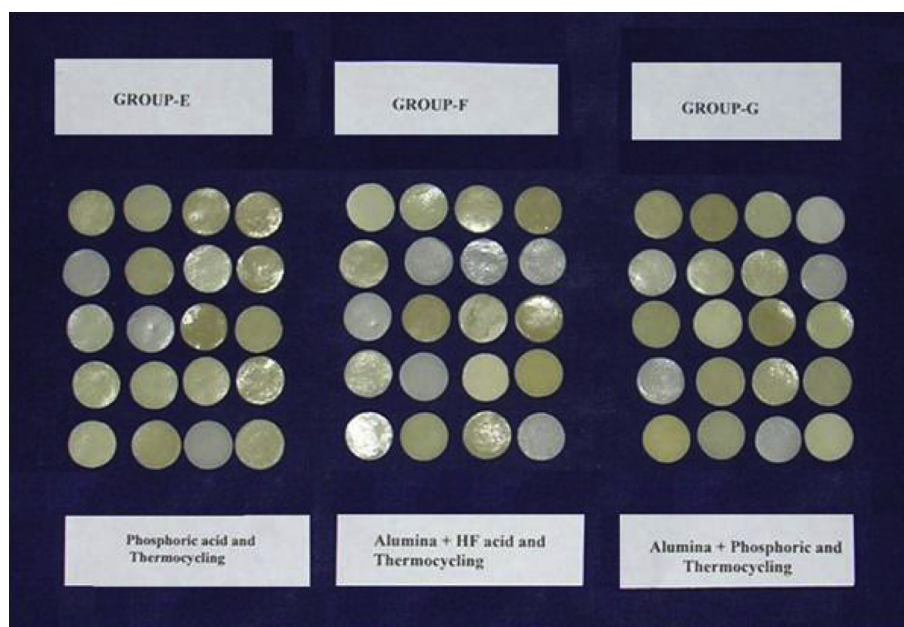
Fig. 1 – Grouping of the ceramic samples into seven different groups.

The specimens were divided into seven groups of thirty specimens each (Fig. 1). They were designated as group A–G.
