Case Report

Prosthetic rehabilitation of a gunshot wound defect with combination of fixed and removable prosthesis

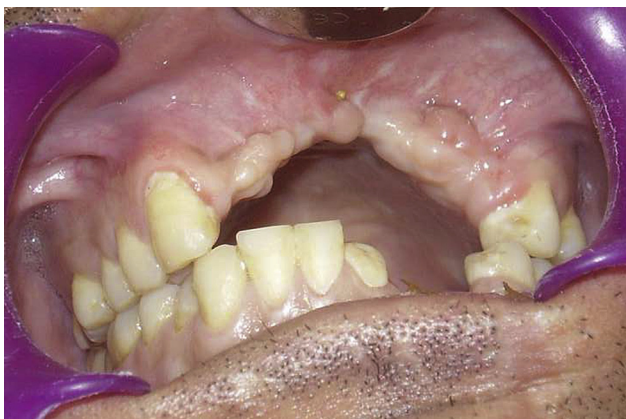
Fig. 2 – Maxillary partially edentulous arch- pretreatment view.

In maxillary arch quadrilateral design cast partial denture with anterior–posterior palatal strap major connector, embrasure clasps in the molar region bilaterally, bar clasp with Cingulum rest in relation to 13, RPI clasp assembly for 25 and mesh retention for acrylic saddle were planned.

Diagnostic impressions of maxillary and mandibular arches were made with irreversible hydrocolloid impression material and diagnostic casts fabricated. Occlusal rest seat preparation in relation to 16, 17, 26, 27 and 25 and cingulum

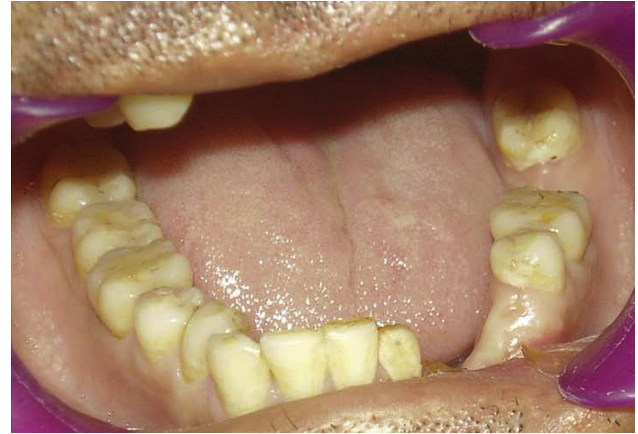
Fig. 3 – Mandibular partially edentulous arch- pretreatment view.

In mandibular arch, root stumps of 32, 33 and 34 were endodontically treated for preservation of associated alveolar bone. Fractured 31 was endodontically treated and restored with fiber post and direct composite resin core. Three unit metal ceramic fixed dental prosthesis for replacing 37 and six unit metal ceramic fixed dental prosthesis for replacing 32, 33 and 34 with 41, 31 and 35 as abutments was planned. The interdental area between the prosthesis was designed as a self cleansing area since patient had a high lip length and thus esthetics was not compromised.

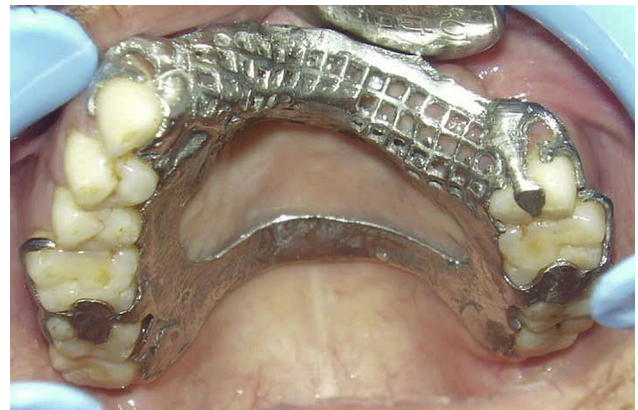
Fig. 4 – Trial of cast partial denture framework.

seat preparation in relation to 13 was carried out. Final impression was made with addition silicone impression material and master cast was fabricated. Surveying of master cast was done to mark height of contours and to locate undercuts. Unfavorable undercuts in the master cast were blocked using blackout wax and clay, and was duplicated with reversible hydrocolloid. Refractory cast was fabricated, hardened and wax pattern was fabricated. Patterns were sprued, invested in a phosphate bonded investment material and casting was carried out in an induction casting machine using chromium cobalt casting alloy. Casting was recovered from investment, trimmed, finished and tried on the master cast. After clinical try-in of the framework in patient's mouth (Fig. 4), it was polished in electrolytic polishing unit. Occlusal rim was fabricated on the framework and jaw relations were recorded with silicone interocclusal records. Casts were articulated and teeth arrangement was carried out. Waxed-up framework was tried in patient's mouth and minor adjustments were made to meet requirements of esthetics and phonetics of the patient. It was processed in heat cured acrylic resin, finished and polished (Fig. 5).
