Clinical case

Immediate loaded implant-supported prosthesis after mandibular reconstruction with free iliac crest bone graft

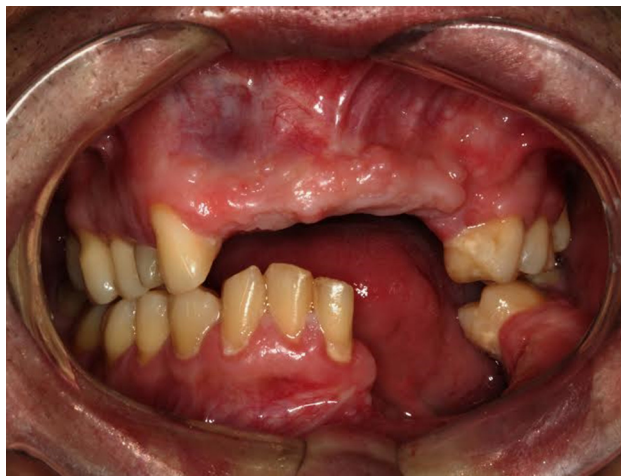
Fig. 1 – Intraoral view of the left mandibular body defect.

A 44 years old man attended the Oral and maxillofacial surgery department for treatment of a mandibular bone defect after injury by firearms. He reported an attempt of suicide about 1 year before. On the clinical evaluation, the facial contour was preserved by a reconstruction plate and the panoramic radiograph showed a bone defect without continuity of the left mandibular body. The stabilization of bone segments was

maintained by a reconstruction plate of load bearing type (Figs. 1 and 2). The proposed treatment plan was the reconstruction of the mandibular defect using free iliac crest bone and after that, an implant-supported rehabilitation.

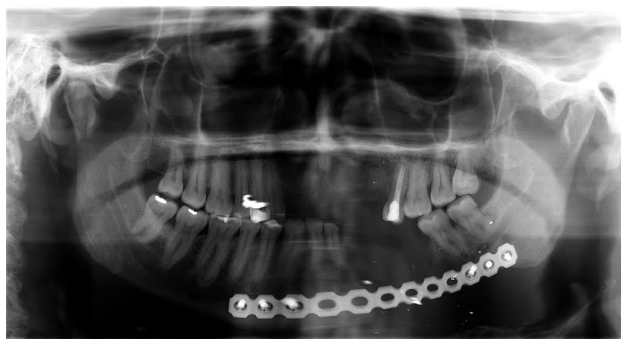
Fig. 2 – Panoramic radiograph view of the left mandibular body defect.
