Ultrasonographic Identification of the Anterolateral Ligament of the Knee

Purpose: To determine ultrasonography's sensitivity for identifying the anterolateral ligament (ALL). **Methods:** A descriptive study of 18 cadaveric knees was performed. Ultrasonography was used to locate any anterolateral structures at the knee that could correspond to the ALL. The structure's length and relation with other notable anatomic landmarks (fibular head, Gerdy tubercle, joint line, lateral femoral epicondyle, popliteus tendon insertion) were quantified. The ultrasonography measurements were validated by dissecting each knee. The sensitivity of ultrasonography for detecting the ALL and the agreement between the ultrasonographic and cadaveric measurements (Cohen κ) were determined by statistical analysis. **Results:** The ALL was found in all 18 cadaveric knees and corresponded anatomically to the ultrasonographic descriptions. Ultrasonography had 100% sensitivity for detecting the presence of the ALL. The ALL's insertion on the lateral femoral condyle was, on average, 12.08 mm (SD, 4 mm; range, 7 to 15 mm) proximal and posterior to the lateral femoral epicondyle and 20.5 mm (SD, 3 mm; range, 16

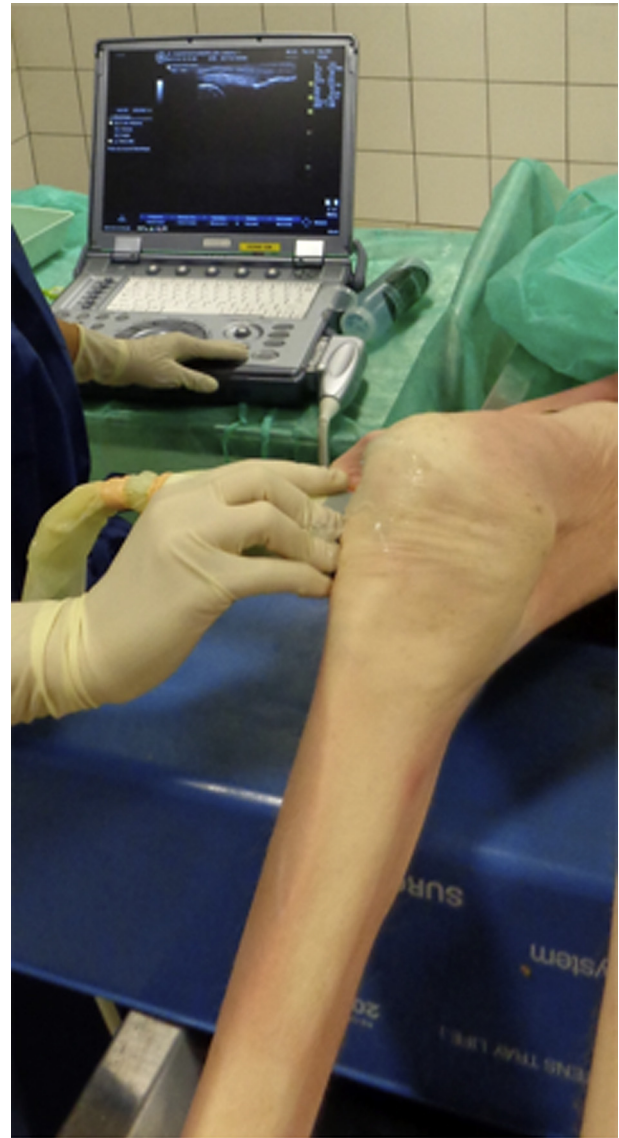
Fig 1. Setup for ultrasonographic portion of study. Once the knee is flexed, an assistant can internally rotate it as needed. A right knee is shown.

A radiologist (M.F.) with experience in musculoskeletal ultrasound imaging performed all the measurements. A 12-MHz superficial probe was used with a Sonosite ultrasonographic unit (General Electric, Milwaukee, WI). The knee was flexed during the examination and then internally rotated as requested by the radiologist to place tension on the ALL¹² (Fig 1). This allowed the radiologist to look for an anterolateral structure at the knee that could correspond to the ALL and was distinct from other anatomic structures in this area. Given that the location of the tibial ALL insertion—but not that of the femoral insertion—is well defined,¹⁵ the radiologist started by identifying the likely tibial (distal) insertion about halfway between the fibular head and Gerdy tubercle. Once this insertion had been located, the ALL was followed to its femoral (proximal) insertion. Once the ALL was identified, the radiologist inserted metal needles into the bone at the ALL's proximal and distal insertions under ultrasound guidance. The length, diameter, and distance between the ALL's insertions and notable local landmarks (Table 1) were determined using the ultrasonographic system's software. This resulted in a topographic map that was compared with published ALL data.^{9,14,15} The tip of the fibular head, middle of the Gerdy tubercle, and middle of the popliteus tendon insertion on the femur were used as reference points.¹²
