Case Report

Dislocation of an S-ROM Total Hip Arthroplasty Secondary to Traumatic Femoral Stem Dissociation from the Metaphyseal Sleeve

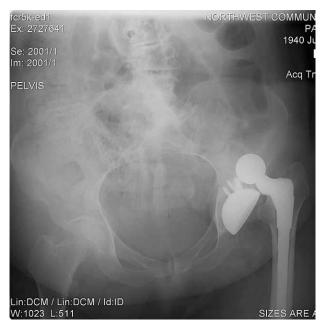
Fig. 1. Radiographs demonstrate dislocation of S-ROM THA after the patient had attempted to sit in a chair of normal height.

One week later, the patient sustained a dislocation after presumably sitting down in a chair of normal height (Fig. 1). The patient presented to an outside institution and underwent an uneventful closed reduction by another orthopedic surgeon. The patient was placed in an abduction brace, cleared physical therapy, and discharged home.

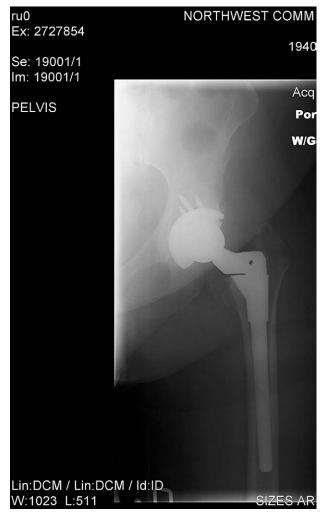
Fig. 2. Radiographs after closed reduction of THA. Component positioning appears adequate with the cup in appropriate anteversion and abduction. There is no evidence of fracture. Version is difficult to assess on this anteroposterior radiograph.

in place, and the plan was to place a 36-mm femoral head. Radiographs demonstrated that the cup was in appropriate anteversion and abduction (Fig. 2). Furthermore, the femoral stem appeared to have appropriate neck length and offset.
