3-Dimensional Analysis of Scaphoid Fracture Angle Morphology

Shai Luria, MD, Yonatan Schwarcz, MD, Ronit Wollstein, MD,
Patrick Emelife, MD, Gershon Zinger, MD, Eran Peleg, PhD

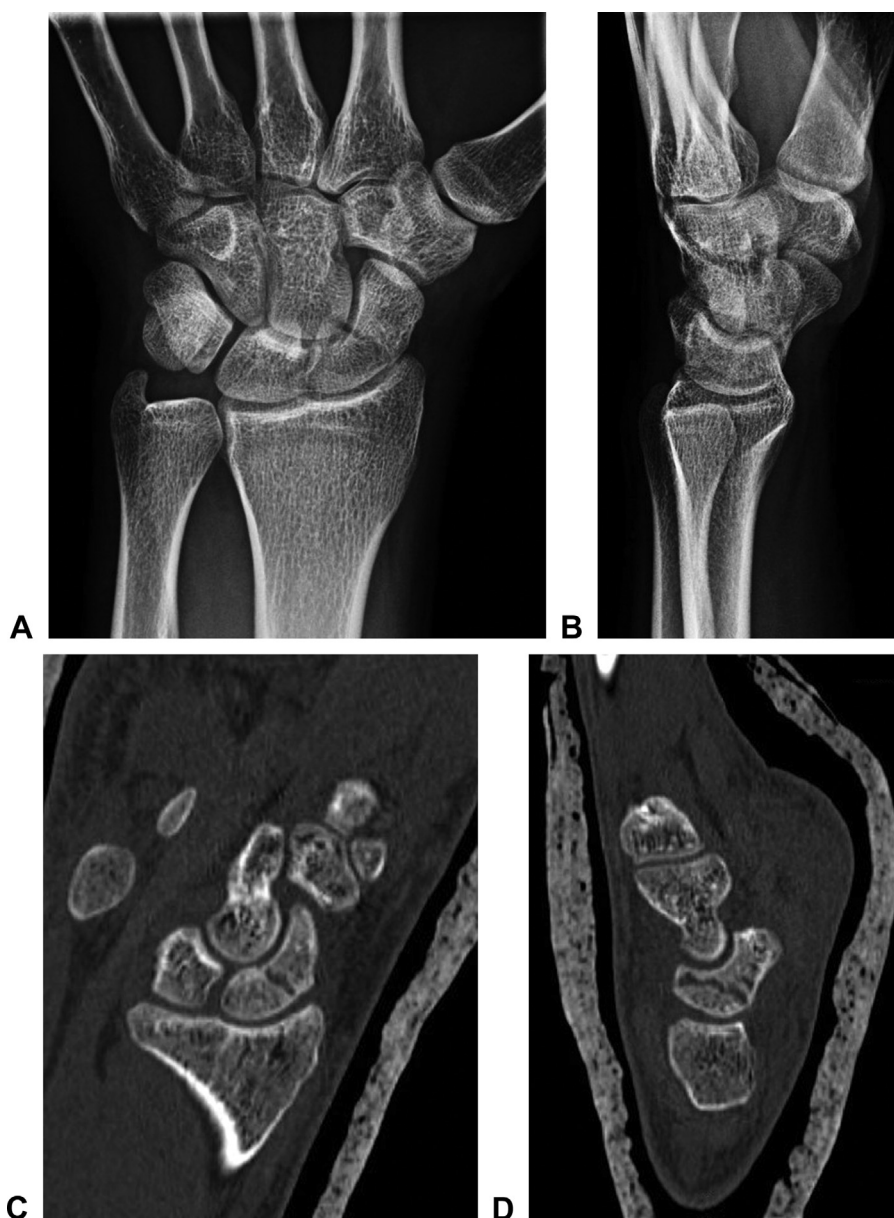
FIGURE 1: Imaging studies of the left wrist of a 19-year-old. The scaphoid fracture was diagnosed a month after the accident. Posteroanterior **A** and lateral **B** radiographs reveal an undisplaced transverse waist fracture. **C, D** Coronal and sagittal CT scan reconstructions are compatible with this description of the fracture.

The radiology department archives were searched for computed tomography (CT) scans of wrists with scaphoid fractures taken between 2005 and 2011, as diagnosed by a radiologist (Fig. 1). No additional examinations were performed and the original scans, with no variations, were used. In our practice, all scaphoid fractures are routinely evaluated with a CT scan. The minimal resolution for the scans was 0.3×0.3 mm and 1-mm slice thickness. Institutional ethics committee approval was obtained.
