Ecological restoration of highway slope by covering with straw-mat and seeding with grass–legume mixture

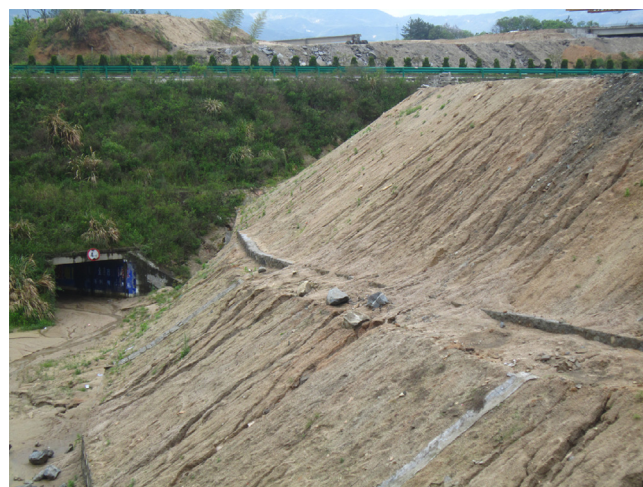
Fig. 1. Distance view of the unrestored highway slope.

The study was carried out on a Yuexi–Wuhan highway slope in the Wanxi Dabie mountain areas, China, between latitudes 30°51′32″N and 30°51′48″N and longitudes 116°19′25″E and 116°19′33″E; the average elevation is 416 m. The climate is subtropical monsoon with a long-term mean annual precipitation of 1498 mm (mainly concentrated in June to August, accounting for more than 70% of the annual rainfall). The mean daily temperature is 14.5 °C; the maximum temperature is 33.6 °C in July, and the minimum is 1.3 °C in January. Owing to the construction of the highway, the original natural soil and vegetation were totally damaged, resulting in a rough, bare slope. A photograph of the unrestored highway slope is shown in Fig. 1. If timely and effective slope protection measures were not taken, the slope soil erosion would be very serious in the rainy season. Therefore, it was

necessary to restore vegetation by some ecological engineering measures according to the special conditions of the highway slope.
