# Copper-silver ionization at a US hospital: Interaction of treated drinking water with plumbing materials, aesthetics and other considerations

Simoni Triantafyllidou<sup>a,\*</sup>, Darren Lytle<sup>b</sup>, Christy Muhlen<sup>b</sup>, Jeff Swertfeger<sup>c</sup>

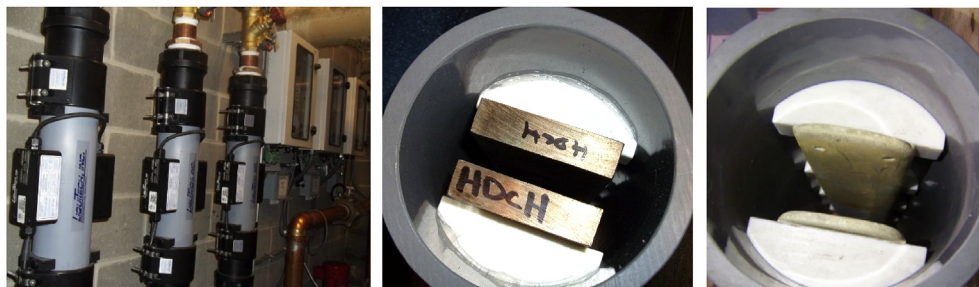
Fig. 1. Three Copper-Silver Ionization (CSI) cells with three corresponding controllers (left) treated incoming water intended for both hot and cold uses. Inside a CSI cell with "fresh" (unused) 70% Cu–30% Ag electrodes (middle). Inside a CSI cell with used electrodes (right).

CSI relies on the synergistic disinfecting capabilities of positively charged cupric ions ( $\text{Cu}^{2+}$ ) and silver ions ( $\text{Ag}^+$ ) (States et al., 1998; Lin et al., 1998). It consists of one or more flow cells, each equipped with two sacrificial copper:silver electrodes (Fig. 1). The composition of the two electrodes (i.e., copper:silver ratio) can be customized. It is typically set to 70:30 copper:silver (weight %), but other ratios have also been reportedly used in various countries (i.e., 50:50, 60:40, 70:30 and 90:10) (Walraven et al., 2015). A direct electric current is applied across the electrodes to stimulate continual release of cupric ions and silver ions into the flowing water, causing the electrodes to be gradually consumed (Fig. 1) and thus have to be replaced periodically.

The hospital has two multi-floor patient buildings (designated as buildings A and B) and applied CSI treatment in February 2014 (i.e., 2/14) to both hot and cold water lines throughout these buildings. Three CSI cells were installed to treat the incoming drinking water (~0.11 million gallons/day for buildings A and B) at the point of entry (Fig. 1). After passing through the CSI cells, water
