Inspection equipment study for subway tunnel defects by grey-scale image processing

Hongwei Huang^a, Yan Sun^a, Yadong Xue^{a,*}, Fei Wang^b

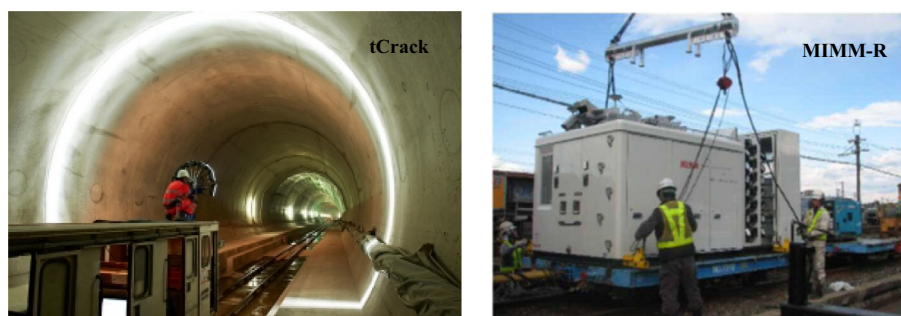
Fig. 1. Typical inspection equipment in subway tunnels.

After many years of research, many countries have developed tunnel inspection equipment based on MVB method [11–15], such as Japan [16] and China [17,18], for road tunnels, and Switzerland [19], for railway tunnels (Fig. 1). Swiss tCrack [19] uses several CCD (Charge-coupled Device) cameras and lights that can recognize cracks of more than 0.3 mm in width, and its full speed is approximately 2.5 km/h. Japanese Keisokukensa.co launched MIMM-R for tunnel inspection. It combines CCD cameras, a laser scanner and Ground Penetrating Radar (GPR), which gives it the ability to inspect cracks, leakage and also tunnel deformation and tunnel lining cavities. As its main function, it can detect cracks and leakage with 0.2-mm resolution at 70 km/h. However, the equipment above needs either a trailer or power supply, which cannot be provided or is too expensive for the tunnel inspection and maintenance department in China. The EURO project also focused on this area, which results in ROBOSPECT [20–22]. This equipment can work in all kinds of working conditions especially tunneling to inspect the crack at the surface of the lining. The equipment uses the laser to construct the 3D image of tunnel and the area-scan camera to obtain the details of the defects. However, finishing the inspection with the full face of tunnel lining is difficult.
