Evaluation of postural sway and impact forces during ingress and egress of scissor lifts at elevations

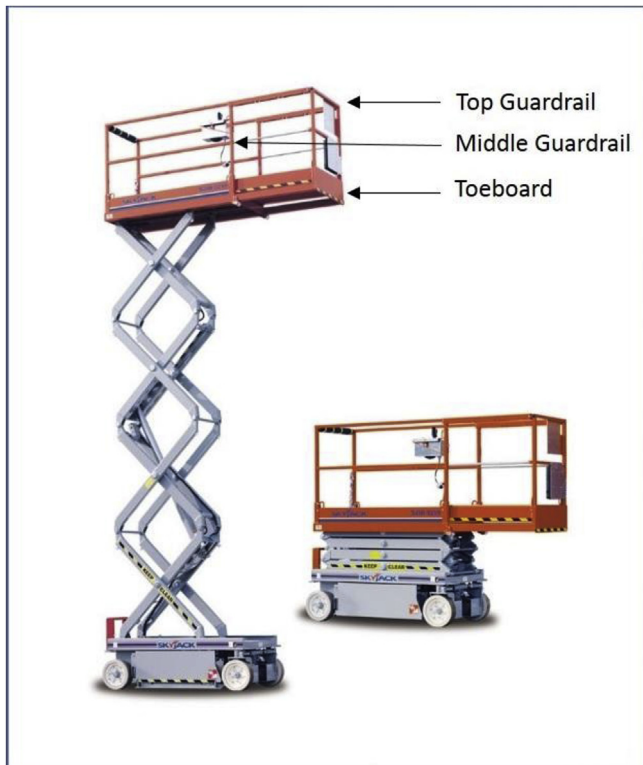
Fig. 1. A demonstration of the structure of scissor lifts (reprinted with permission of Skyjack Inc.).

Scissor lifts (Fig. 1) are commonly found at many construction sites, and when used properly they can facilitate completion of many construction tasks. Over the past decade, the use of scissor lifts has increased significantly in industries such as construction, telecommunication, and warehousing and storage. Their growing popularity makes scissor lift safety an important issue. The scaffolding industry has long recognized fall hazards associated with work on scissor lifts (Burkart et al., 2004; Heath, 2006; McCann, 2003). A study of the Census of Fatal Occupational Injuries (CFOI) data found that falls from vertical lifts accounted for 44% of vertical-lift deaths, almost all involving scissor lifts (McCann, 2003). A later study conducted by the National Institute for Occupational Safety and Health (NIOSH) confirmed the increasing trend for fatalities associated with falls from scissor lifts and further identified that extensibility factors—the extended height of the lift or the vertical

A commercially available 5.79 m (19 ft) electric scissor lift (Model SJIII 3219, Skyjack, Inc, Ontario, Canada) was used for the study. The SJIII 3219 scissor lift platform has a deck extension, a gate for ingress and egress, guardrails around its periphery, as well as toeboards on all sides (Fig. 1). This lift platform has a length and a width of approximately 0.73 and 1.6 m (29 and 64 inches), respectively, and a deck to extend overall length to approximately 2.54 m (100 inches). The guardrails, composed of a toprail and a midrail, have a height of 0.99 m (39 inches). The toeboard is about 0.15 m (6 inches) high. This type of scissor lift has a total load-bearing capacity of 249.4 kg (550 lbs). The separate rated load-bearing capacity on the main lift platform and 0.9-m (3-ft) deck are 113.3 and 136.0 kg (250 and 300 lbs), respectively. These specifications conform to ANSI standard A92.6 for Self-Propelled Elevating Work Platforms.
