Transportation Geotechnics and Geocology, TGG 2017, 17-19 May 2017, Saint Petersburg, Russia

Geological-engineering and geotechnical issues concerning the function of the railway bridge across the Amgun' river operated by the Far Eastern Railway

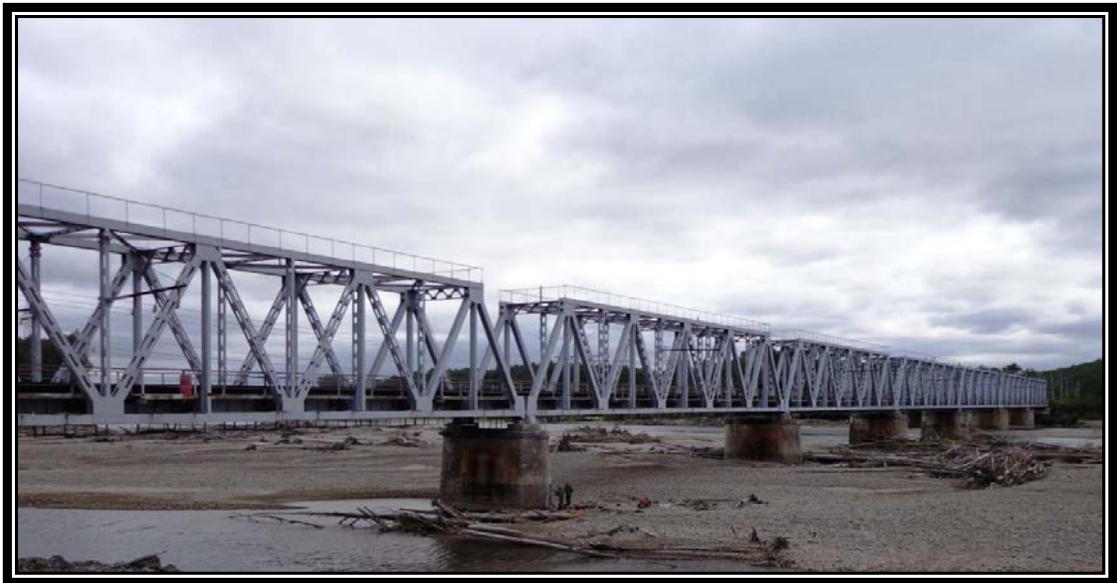
Fig. 1. General view of the bridge across the Amgun’ River. The riverbed part of the bridge crossing is set up of quaternary alluvial deposits. Steel trusses with parallel chords; deep foundations and supports are built of site concrete.

In order to resolve these issues we have performed a whole complex of research procedures applied to the big bridge across the Amgun’ river on the railway line Komsomolsk-on-the-Amur – Novy Urgal belonging to the Far Eastern Railway (the former section of the Baikal Amur Mainline). The bridge was put into operation in 1949. It has seven steel spans performed as trusses with parallel chords with a design span of 55.0 m. The complete length of the bridge is 403.41m. Supports and deep foundations are built of site concrete (Fig. 1)
