9th International Conference "Bridges in Danube Basin 2016", BDB 2016

## Highway Viaduct Renovation

### Summary

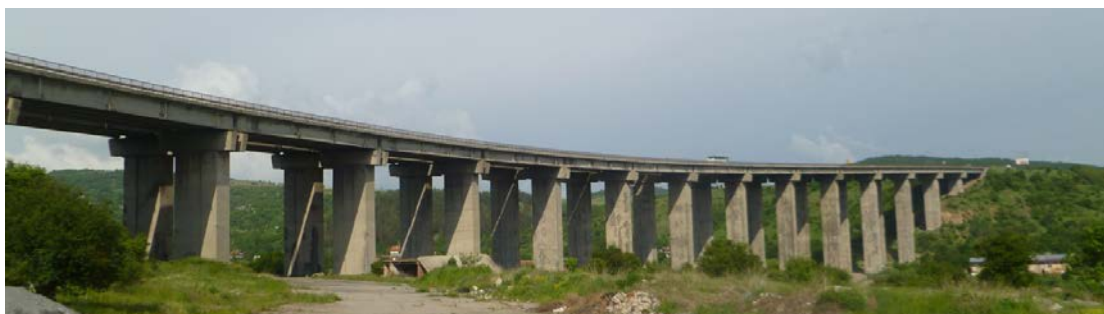
Fig. 1 Longitudinal view of the viaduct

The viaduct has multi-span, simply supported superstructure. Each span is 40.5m long and there are 16 spans in number, so the total length of the bridge is approximately 650m. The beams in longitudinal direction are connected with continuous slab laid over the piers. The viaduct is divided in longitudinal direction in three parts with four expansion joints - two on the abutments and two in-between the ends. Intermediate expansion joints are allocated on the piers №5 and №11 respectively. The expansion joints are of a modular type. The superstructure is constructed with four precast post-tensioned beams, 39m long and around 120t in weight. The beams span is 38m. The deck slab is executed from precast element with 299cm by 305cm in size and 20cm thickness in cross direction. The connection between the precast panels is done with cast-in-situ concrete on top of the precast beams with suitable reinforced detail. This cast-in-situ joint combines the slab with the precast beams and the precast slab elements (see fig 1a). The superstructure has two cross beams at the end of each span. No intermediate cross beams are used.

The viaduct is positioned on the highway, connecting the city of Sofia with the northern part of Bulgaria. The total length of the viaduct is 645m, where it has 16 spans of 40.5m length each. The maximum height of the piers is 50m.
