Two-View Gravity Stress Imaging Protocol for Nondisplaced Type II Supination External Rotation Ankle Fractures: Introducing the Gravity Stress Cross-Table Lateral View

Troy J. Boffeli, DPM, FACFAS¹, Rachel C. Collier, DPM, FACFAS², Samuel J. Gervais, DPM³

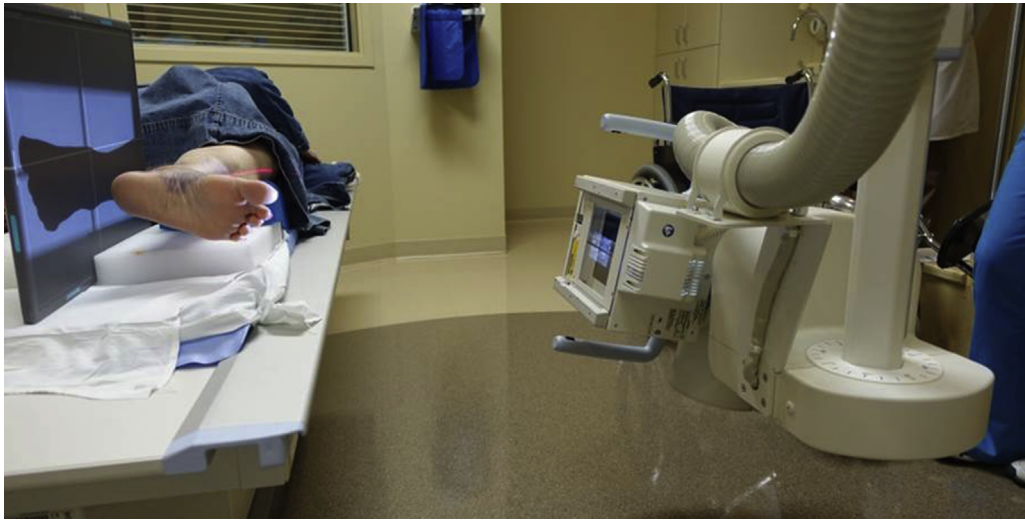
Fig. 1. The traditional gravity stress mortise view is performed with the patient lying in the lateral position with the affected limb down. A foam block is placed proximal to the fibula fracture. The foot is allowed to relax or dangle in an externally rotated position, which produces gravitational stress through the ankle fracture.

We instituted a 2-view gravity stress imaging protocol several years ago for all patients presenting with seemingly SER-II nondisplaced fibula fractures. In addition to the traditional gravity stress mortise view (Fig. 1), a gravity stress cross-table lateral view (GSCTLV) is obtained (Fig. 2). To the best of our knowledge, the GSCTLV has not previously been described in reported studies. This 2-view protocol obviates the need to repeat 3 standard ankle views when the patient presents days later to the specialty clinic. It also provides a more

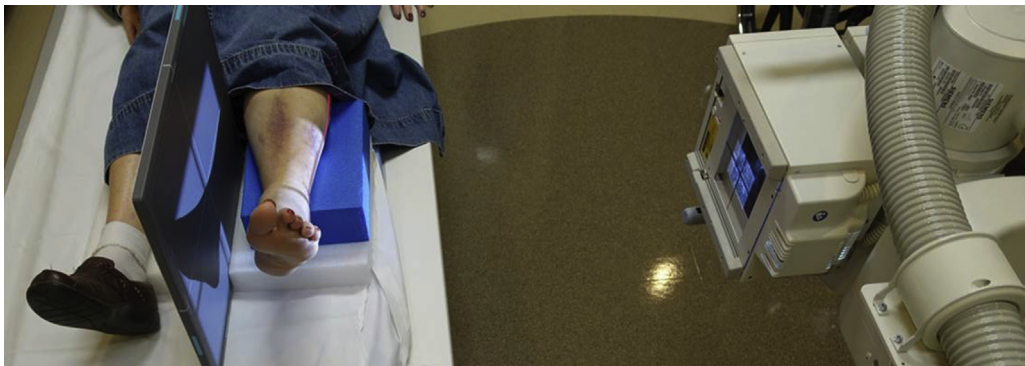
Fig. 2. The gravity stress cross-table lateral view is obtained with the patient lying supine on the table. A foam block (blue) is used to support the limb just proximal to the fibula fracture. The leg is slightly externally rotated, and the foot is allowed to relax in a slightly plantarflexed and externally rotated position. The x-ray cassette is placed on the medial side on the ankle, and a cross-table lateral image is taken.
