# Forced eruption of impacted maxillary central incisors with severely dilacerated roots

Treatment of impacted dilacerated incisors is challenging for clinicians because of the prominent position of the teeth and the abnormality of their roots. We report on 2 patients who had horizontally upward impacted and severely dilacerated maxillary central incisors. The first patient's root perforated the labial plate without significant resorption, and the second patient's root was resorbed. Both patients were treated by a surgical-orthodontic approach, and the crowns of the impacted teeth were brought into the arches by closed forced eruption. Therefore, if impacted teeth have dilacerated roots, patients should be told of the possibility of root resorption. (*Am J Orthod Dentofacial Orthop* 2016;150:692-702)

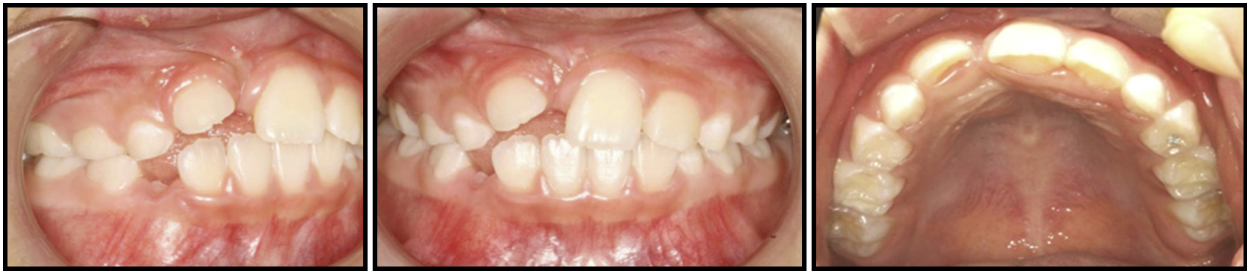
**Fig 1.** Patient 1: pretreatment intraoral photographs.

Patient 1 was a 7-year-old girl with the chief complaint of an impacted maxillary right central incisor. There was nothing relevant in her medical or dental history. She had an impacted maxillary right central incisor, which, along with the left central incisor, was tilted into the open space, and the dental midline of her maxillary arch was deviated by 2.5 mm to the right (Fig 1). Radiographs confirmed that the maxillary right central incisor was impacted with dilaceration on the root (Fig 2). The cone-beam computed tomography (CBCT) images taken for further evaluation showed that the crown of the maxillary right central incisor was just below the nasal floor in the premaxilla, with the palatal surface facing forward. Compared with the maxillary left central incisor, the root of the impacted incisor was short, and the apical third was dilacerated upward (Fig 3).
