CASE REPORT

Foreign body of endodontic origin in the maxillary sinus

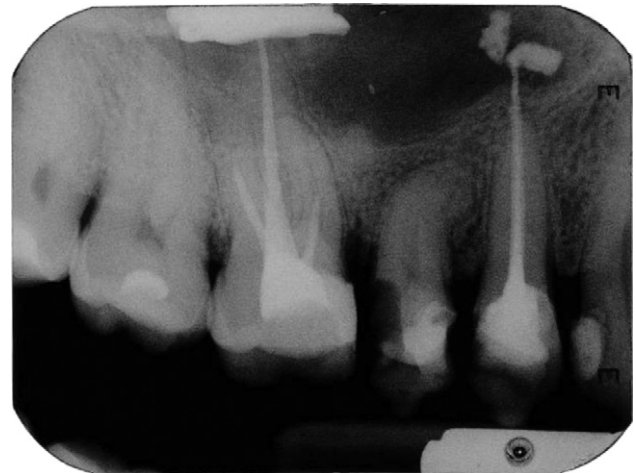
Figure 1 X-ray projection, including teeth 14 and 16.

A 45-year-old generally healthy male patient reported to the Department of Conservative Dentistry with Endodontics, Medical University of Silesia, because of orbital and buccal pain on the right side of the face and headaches in the preceding 6 months. The symptoms were associated with the end of endodontic treatment of teeth 14 and 16. Periapical X-rays, including of teeth 14 and 16, showed the presence of root-canal filling with extrusion of endodontic obturation material beyond the apices of tooth 14. In the case of tooth 16 a completely filled palatal canal and incompletely filled buccal canals were found. There was also an irregular dimness at the upper edge of the X-ray image, which suggested an artefact that appeared during the X-ray preparation (Fig. 1). Panoramic radiography revealed an irregular, radiodense foreign body in the right maxillary sinus. A foreign body with irregular borders was observed to have spread to the maxillary sinus wall away from the apical region of the involved tooth 14 (Fig. 2).

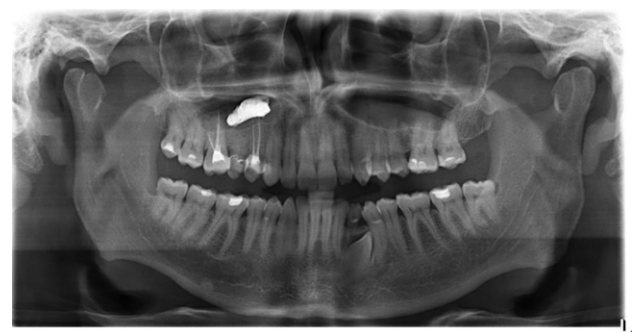
Figure 2 Panoramic radiograph revealing a radiodense, irregular foreign body in the right maxillary sinus.
