## Complex coronoid and proximal ulna fractures are we getting better at fixing these?

Richard S. Yoon, MD<sup>a</sup>, Vineet Tyagi, MD<sup>b</sup>, Matthew B. Cantlon, MD<sup>a</sup>, Aldo M. Riesgo, MD<sup>a</sup>, Frank A. Liporace, MD, Associate Professor<sup>a,\*</sup>

<sup>a</sup>Division of Orthopaedic Trauma, Department of Orthopaedic Surgery, NYU Hospital for Joint Diseases, New York, NY, USA

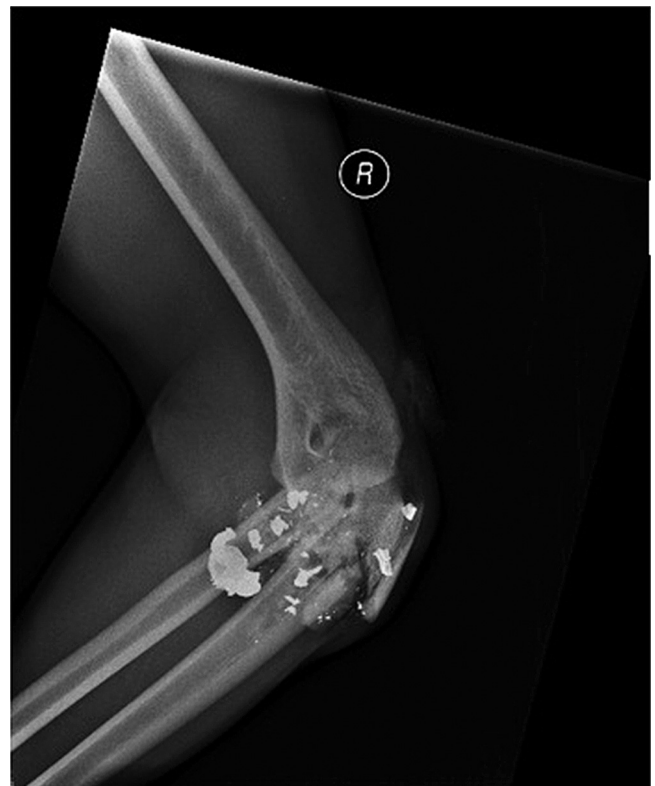
**Fig. 1.** Complex proximal ulnar and olecranon fractures typically occur from mechanisms outside from your standard fall.
