Driver behavior during bicycle passing maneuvers in response to a Share the Road sign treatment

Jonathan J. Kay, Peter T. Savolainen*, Timothy J. Gates¹, Tapan K. Datta²

Wayne State University, Department of Civil and Environmental Engineering, 5050 Anthony Wayne Drive, Detroit, MI 48202, United States

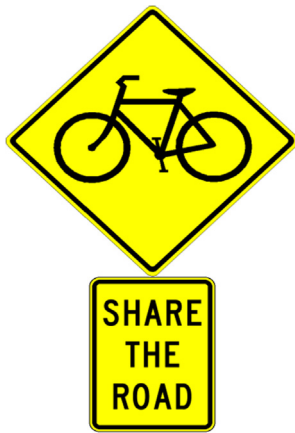
Fig. 1. Bicycle Warning Sign (W11-1) with “Share the Road” Plaque (W16-1) (FHWA, 2009).

One safety treatment that is aimed specifically at improving interaction between motorists and bicyclists is the bicycle warning sign (MUTCD W11-1), shown in Fig. 1, which can be used in conjunction with a “Share the Road” plaque (MUTCD W16-1). According to the Manual on Uniform Traffic Control Devices (MUTCD), the bicycle warning sign (W11-1) is intended to warn road users of unexpected entries by bicyclists into the roadway (FHWA, 2009). The “Share the Road” plaque may be added when there is a need to warn motorists about bicyclists traveling along the roadway (FHWA, 2009). Given the relatively low costs for providing such signage, research as to its effects provides valuable evidence to guide subsequent decision-making by road agencies. To date, no research has assessed the impacts of the W11-1 sign on driver behavior, though a similar pedestrian warning sign (W11-2) was previously shown to result in marginal improvements in driver compliance at select locations (Clark et al., 1996).
