Canadian Association of Radiologists Journal xx (2016) 1–8

Musculoskeletal Radiology / Radiologies musculo-squelettique

Osseous Injury Associated With Ligamentous Tear of the Knee

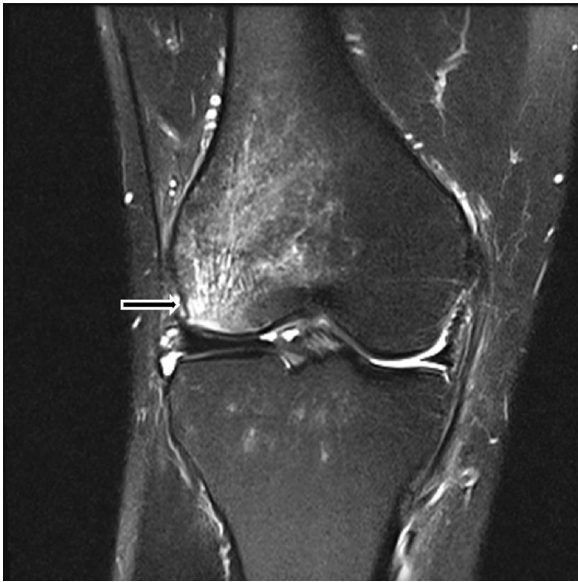
Figure 1. Bone bruise related to anterior cruciate ligament (ACL) tear of the knee. A 43-year-old man complained of knee pain and limited range of motion after a fall 3 weeks earlier. The knee radiograph (not shown) was unremarkable. Coronal T2-weighted fat-suppressed magnetic resonance imaging (MRI) reveals a high signal at the lateral femoral condyle (arrow), which is consistent with the presence of a bone bruise. A wavy, discontinuous ACL was identified on sagittal T2-weighted MRI (not shown), which was confirmed by arthroscopy.

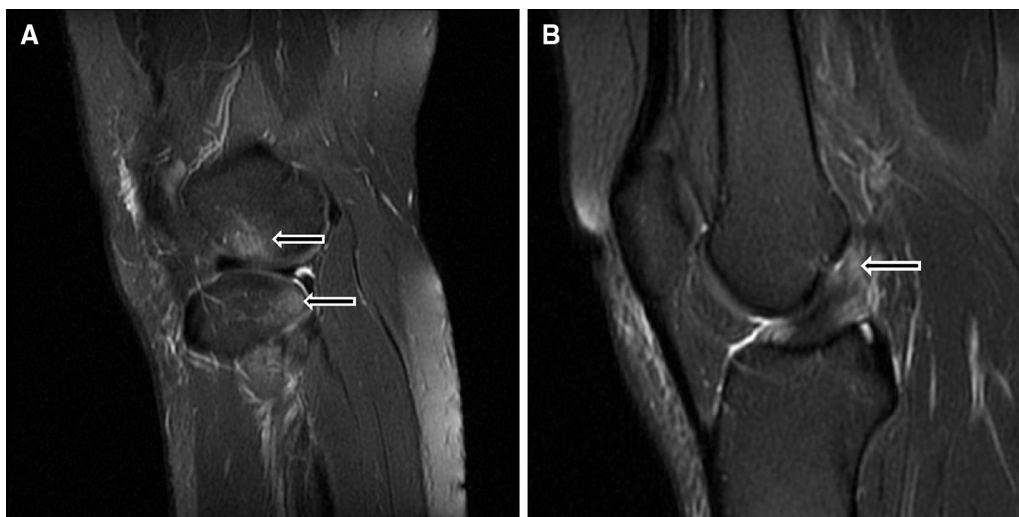
Figure 2. Associated marrow contusion related to anterior cruciate ligament (ACL) tear of the knee. A 27-year-old woman complained of knee pain and swelling for several days after a fall. Radiograph (not shown) failed to reveal any fractures. (A) Sagittal T2-weighted fat-suppressed magnetic resonance imaging (MRI) shows associated marrow contusion (arrows; high signals at the lateral femoral condyle and posterior aspects of the lateral tibial plateau), which commonly occur in ACL tear cases. (B) Sagittal T2-weighted fat-suppressed MRI reveals the ACL tear (arrow), which was confirmed by arthroscopy.
