Distal Corporal Anchoring Stitch: A Technique to Address Distal Corporal Crossovers and Impending Lateral Extrusions of a Penile Prosthesis

Key Words: Distal Corporal Crossover; Impending Lateral Extrusion; Penile Prosthesis

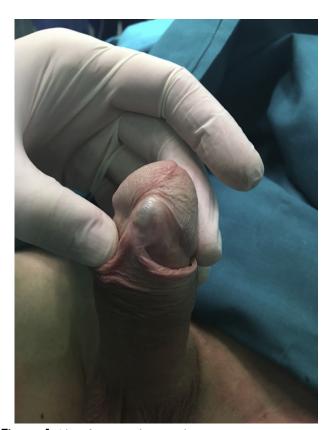
Figure 1. Identification of impending extrusion or crossover. Figure 1 is available in color at www.jsm.jsexmed.org.

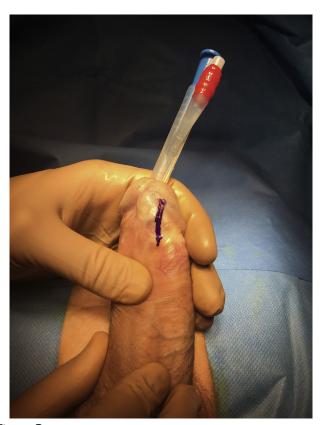
Figure 2. Longitudinal incision localization. Figure 2 is available in color at www.jsm.jsexmed.org.

Methods: A lateral sub-coronal incision is used on the side where the crossover or laterally extruding cylinder should be positioned. Dissection is carried through the Buck fascia, followed by a transverse incision of the tunica albuginea, where the distal aspect of the affected cylinder is delivered. A 4-0 PDS suture is threaded through the distal cylinder ring of the implant. A new, properly positioned intracorporal channel is created and the suture is passed through the distal end of the channel. Once the suture is through the glans and the cylinder is in the correct position, a small cruciate incision is made on the glans at the location of the anchor stitch. The suture is tied with the knot buried in the glans tissue.
