Reliability study of an emerging fire suppression system

**By David A. Miller,
Lyric M. Rossati,
Nathan K. Fritz,
Michael E. Cournoyer,
Howard N. Granzow**

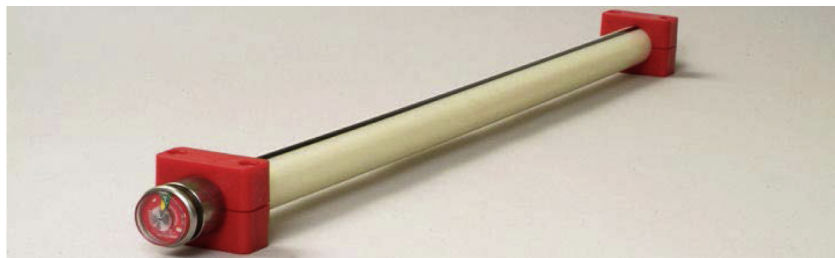
Figure 1. Self-contained fire extinguisher tube.

Plutonium gloveboxes are known to be a harsh environment for polymer materials. Radiation, chemical exposure, inert atmosphere, and dry (low humidity) atmosphere have high potential to degrade the lifetime of engineered components.⁵⁻⁷ In the Fire Foe™ system, the primary component of interest is the nylon 6-6 machined tube that comprises the main body of the system, as seen in Figure 1.
