## Journal of Geochemical Exploration

## Vitrification of urban soil contamination by hexavalent chromium

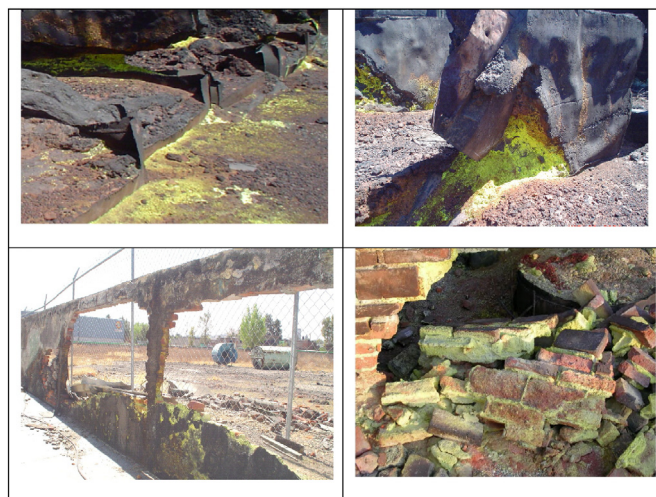
Fig. 1. Various aspects of the soil and location contaminated by chromates in Lechería and Tultitlán (México) (Ballesteros, 2014).

In all cases, the samples were taken from surface outcrops of chromate (very evident due to the presence of yellow and greenish-yellow stains) except for the extraction of sample M2, which was taken at a depth of up to 3 m.
