## **Palliative Care Rounds**

# Complications of a Gastrostomy Tube Used for Decompression of an Inoperable Bowel Obstruction in a Patient with Advanced Cancer

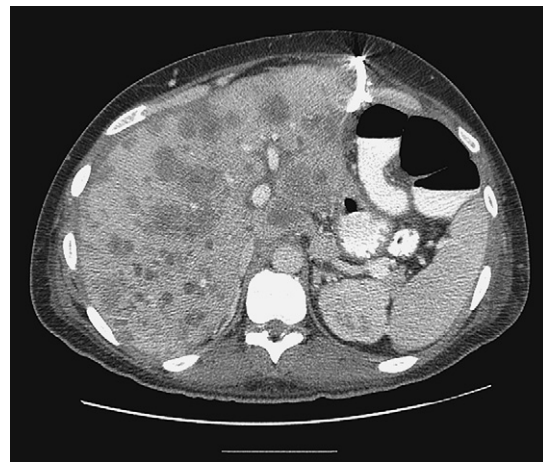
Fig. 1. Computed tomography scan of the abdomen revealing the G-tube lying in the anterior stomach wall with a trail of contrast material leading into the patient's stomach.

However, when the patient attempted to move, he felt a "pop" in his epigastric area associated with pain and an increase in nausea. The results of physical examination were unchanged, but during the next 24 hours, the nursing staff reported a decrease in output from the patient's G-tube. Repeat abdominal radiographs were unremarkable, and the G-tube was examined at bedside by a clinician who found it to be functional. Because his symptoms persisted, computed tomography scan of the abdomen and pelvis was performed and revealed that the G-tube had gone astray and was lying in a fistulous tract formed by his G-tube in the anterior stomach wall. Contrast material was administered through the G-tube, and a trail of dye was noted leading through the fistula to the stomach (Fig. 1). The patient's G-tube was examined fluoroscopically by an interventional radiologist, who found that the catheter tip was misplaced outside the gastric lumen. The G-tube was subsequently exchanged and a new tube properly positioned, resulting in improvement of symptoms.
