Spall damage repair using 3D printing technology

Jaeheum Yeon^{a,*}, Julian Kang^b, Wei Yan^c

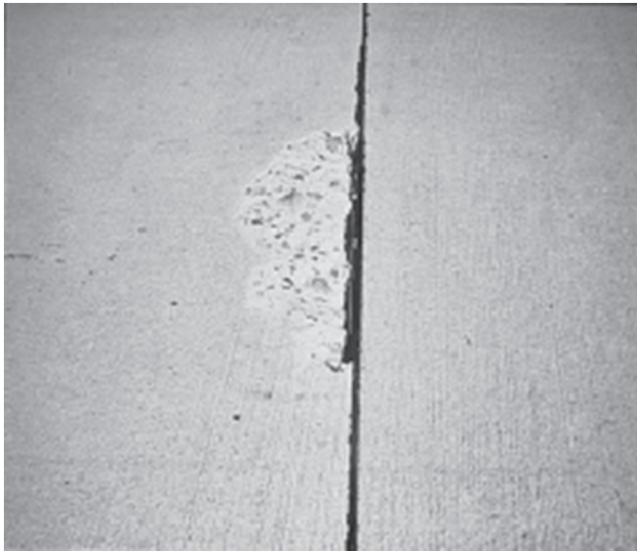
Fig. 1. Representative spall damage on the edge of a concrete slab [7].

road's durability. As a means of prevention, transversal joints are often inserted at predetermined positions [6]. This helps prevent road cracking in undesirable locations. These transversal joints are filled with a stretchable sealant to stop water from penetrating, even if a gap in the joint increases due to concrete shrinkage. If concrete roads crack along an artificially created transversal joint, the concrete slab segments become structurally disconnected and begin to act independently over time. Depending on the condition of the ground, the heights of the two slab segments along the transversal joint may not seamlessly match. As a result, a vehicle passing over this point may rattle and suffer additional shock loads. If this impact load is repeatedly applied, the edge of the slab will break into palm-sized pieces, as shown in Fig. 1.
