Experimental and numerical investigation of cyclic response of a glass curtain wall for seismic performance assessment

Carolina Aiello ^{a,*}, Nicola Caterino ^{a,b}, Giuseppe Maddaloni ^{c,b}, Antonio Bonati ^b, Annalisa Franco ^b, Antonio Occhiuzzi ^{b,a}

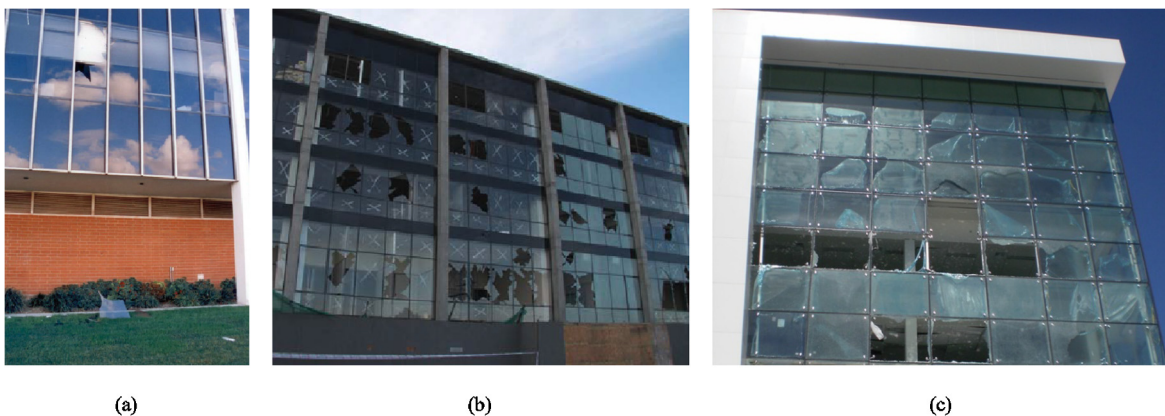
Fig. 1. Glazing damage observed in past earthquakes: (a) 1994 Northridge Earthquake, (b) 2010 Chile Earthquake, (c) 2011 Christchurch Earthquake [2,3].

During an earthquake, potential failure of one of the infill panels can be an extremely dangerous threat to the exposed public inside or outside the building (Fig. 1). If the façade is not properly designed and installed, the drift between adjacent storeys induced by the earthquake accelerations could provoke glass (or any other cladding material) breakage and potential fallout [1].
