# Influence of alkali carbonate reaction on compressive strength of mortars with air lime binder

This paper investigates the process of alkali-carbonate reaction (ACR) in air lime mortar prepared with Triassic dolomite aggregate. The progress of the ACR at various exposure conditions, i.e. accelerated conditions of 1 M NaOH at 60 °C, distilled water at 60 °C, and 1 M NaOH solution at 20 °C, and reference conditions (water at 20 °C) was studied using petrographic microscope and scanning electron microscopy with X-ray microanalysis (SEM/EDS). As a control, an air lime mortar with inert limestone aggregate was prepared and submitted to the same conditions. Parallel and complementary to the microscopic investigation, the compressive strength, weight and length of the mortar bars was measured over the exposure time. The results of the tests indicate that the presence of hydroxide ions in the binder is sufficient to trigger and promote the ACR in the lime mortar with dolomite aggregate. More alkaline conditions brought about by alkali hydroxides and the higher temperature of 60 °C accelerate the reaction. Compressive strength of the lime mortar with dolomite aggregate, exposed to water

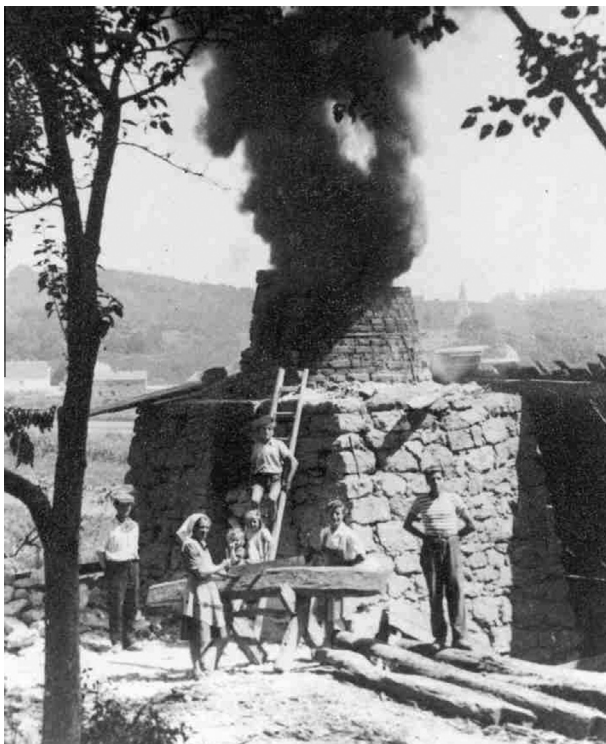
Fig. 1. Lime kiln from Goričko.

Lime used to be the traditional binder also in Slovenia. Small-scale production, sufficient for local community needs, was typical for the country. The lime kiln from Goričko, Slovenian region between the Austrian and Hungarian borders, made from limestone blocks and clay bricks, is a typical representative of the local

community lime kilns (Fig. 1). Fortunately, there are still some small lime kilns all over Slovenia that are producing quick lime and lime putty in the traditional way. Therefore, limited amounts of traditional dolomite (mainly) or calcite (rarely) lime putty for the preparation of lime mortars and lime washes are still available.
