Out-of-plane behavior of two-layered free-standing masonry walls: Analytical solutions and small-scale tests

This study explores the possibility of adopting small-scale models for understanding the behavior of two-layered masonry walls. The units were made of gypsum powder and produced by a 3D printer. The tests were conducted by means of a tilting table, which provided a first order seismic analysis leading to the discovery of the minimum value of the horizontal/vertical acceleration ratio that triggers the collapse. In order to conduct a qualitative analysis, a high-speed camera and dedicated software were employed. Beforehand, theoretical predictions were given (expressed by dimensionless parameters) both for the failure domain and failure angle. Experimental tests showed that for various failure mechanisms, different reduction factors should be applied – because of the interference of imperfections. Additionally, at the borders between some failure modes, mixed modes can occur with an unfavorable effect on load capacity. A high-speed camera and software utilization helped to explain the asymmetric frame-like failure mechanism occurrence which could not have been predicted theo

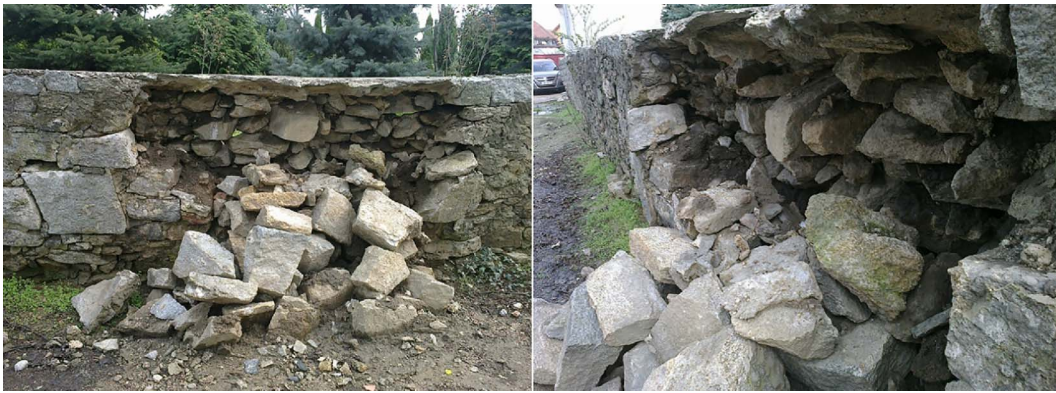
Fig. 1. Free-standing two-layered wall in rural Poland, damaged through the separation of layers.

Multilayered walls rarely occur (besides fortification, historical ruins, municipal or retaining walls) as free-standing isolated elements (Fig. 1). However, in order to understand their behavior and role in more complex structures, their performance as generic elements has to be correctly understood and quantified. Out-of-plane behavior of multi-
