Effectiveness, durability and wear of anti-slip treatments for resilient floor coverings

S. Derler*, R. Huber, F. Kausch, V.R. Meyer

Empa – Swiss Federal Laboratories for Materials Science and Technology, Laboratory for Protection and Physiology, Lerchenfeldstrasse 5, CH-9014 St. Gallen, Switzerland

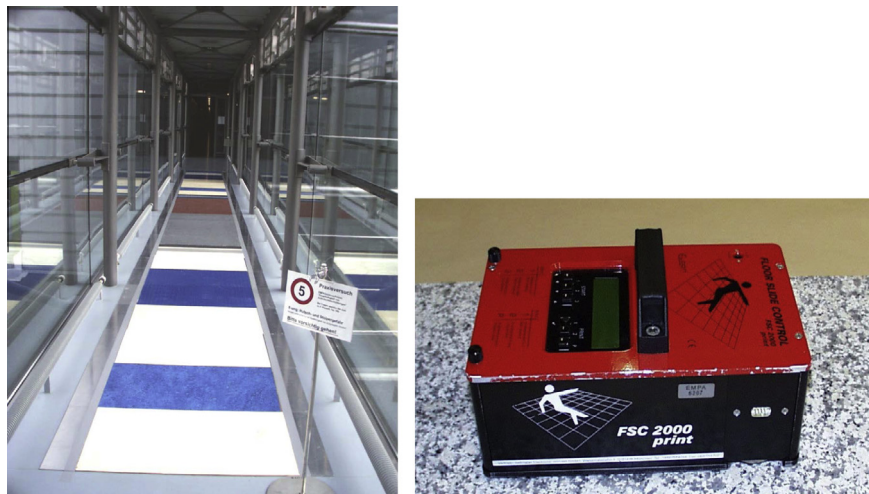
Fig. 1. Long-term experiment concerning the effectiveness and durability of anti-slip treatments (left) and the portable tribometer FSC 2000 used for friction measurements (right).

Anti-slip treated samples of floor coverings and untreated reference samples were installed in an indoor corridor of an institute building (Fig. 1) in order to study their effectiveness and durability by means of periodic friction measurements over a period of one year. The pedestrian traffic in the corridor was monitored by a photoelectric beam which registered around 700 passages per day and about 250,000 passages during the entire experiment. The shoes of the persons passing through the corridor were not monitored. Mechanical wear, soiling, and periodic cleaning were the main factors the floor surfaces were subjected to.

The slip resistance of the surfaces was determined using the portable tribometer FSC 2000 (Fig. 1) which was discussed by Skiba et al. (1994a, 1994b) and Chang et al. (2001a). The device was operated at a velocity of 0.2 m/s over a distance of 0.3 m in
