Review

Ultimate strength of cracked ship structural elements and systems: A review

Ashkan Babazadeh, Mohammad Reza Khedmati*

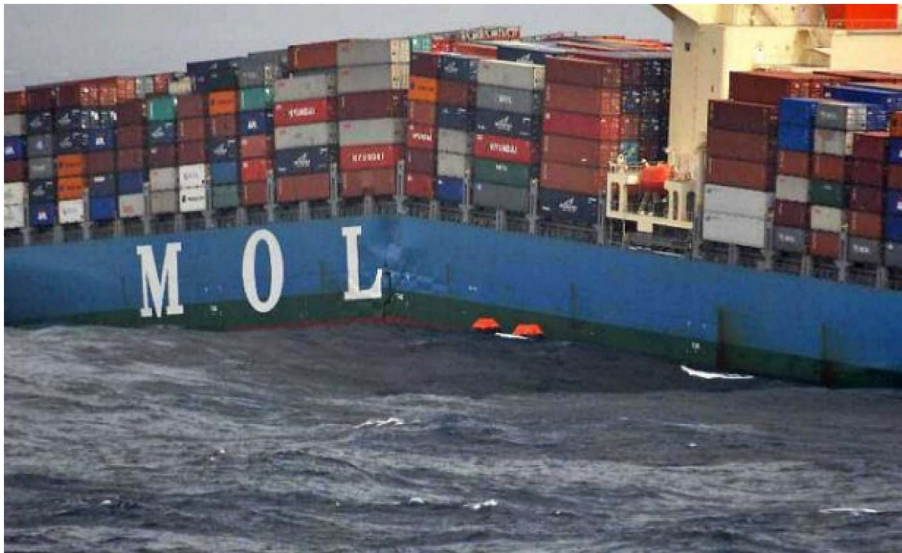
Fig. 1. MOL Comfort before breaking into two. Image credit: IANS NEWS [1].

For the ships having cracks, the casualty may be so sudden that cannot be prevented readily, since it is impossible to find and repair the crack during the ship's operation. Thus, assessment of the effects of the cracks on the strength of plates, stiffened plates and ship hull girders is as important as study of the outcomes of the corrosion and other defects. Fig. 1 shows the MOL Comfort at the early minutes of the casualty.
