Buckling failure analysis of all-terrain crane telescopic boom section

Jia Yao^a, Xiaoming Qiu^a, Zhenping Zhou^{b,*}, Yuqin Fu^c, Fei Xing^a, Erfei Zhao^b

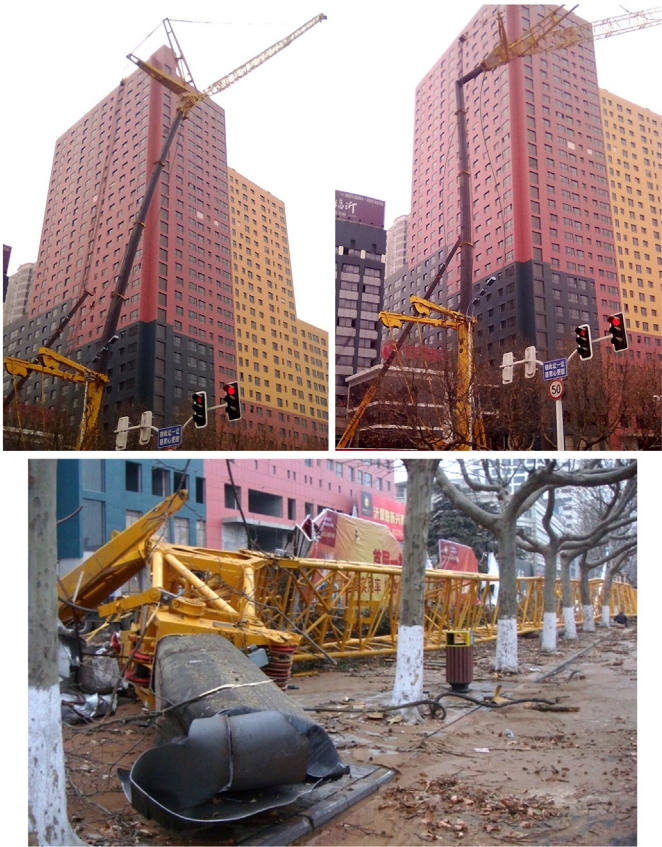
Fig. 1. Failure of all-terrain crane telescopic boom.

An all-terrain crane has the features of high capacity, extraordinary mobility and convenient operability, and is usually used in projects such as high building construction and wind power equipment installation. The telescopic boom is an important load-bearing structure of an all-terrain crane, which consists of multiple independent thin-walled sections, with each section being made of unequal thickness high strength steels through bending and welding processes, and the cross-section shape being similar to an oval [1,2]. When the crane is in operation, the telescopic boom bears the coupling action of regular loads such as gravitational force, hosting load, inertia loads, and occasional loads such as wind loads or skewing loads caused by the uneven supporting legs, influenced by design, material, processing, construction environment, operational errors, the local buckling prone to occur at telescopic boom, causing accidents. Local buckling failure accident of an all terrain telescopic boom occurred in China as shown in Fig. 1.

Structure experiment was designed based on the boom load characteristics in accident and analyzed using nonlinear static method and explicit dynamic method; the connection of load, boom buckling failure and stress wrinkle was studied. The result indicated that the accident was caused by elastic buckling. When the telescopic boom stress state changed from continuous state to wrinkle state, the buckling occurred. So the critical buckling state characteristic was stress wrinkle.
