Fatigue life of girders with trapezoidally corrugated webs: An experimental study

B. Kövesdi*, L. Dunai

Budapest University of Technology and Economics, Department of Structural Engineering, Műegyetem rkp. 3, H-1111 Budapest, Hungary

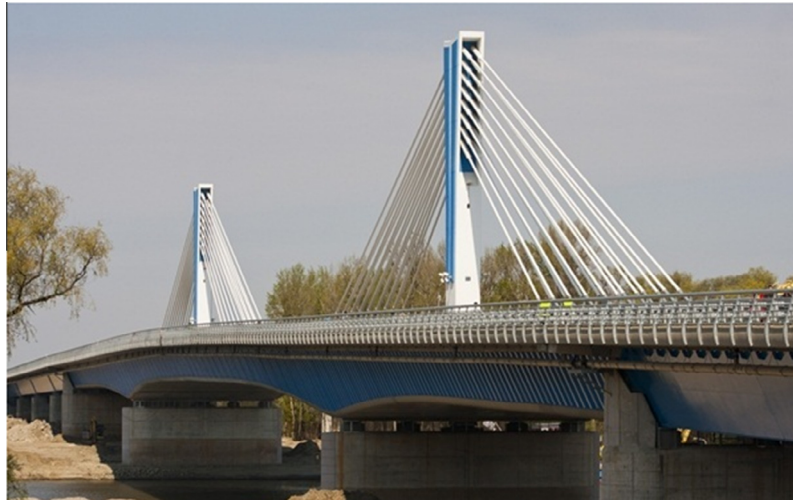
The Móra Ferenc bridge at the M43 highway over the Tisza River was designed and constructed with corrugated steel webs in Hungary between 2006–2011. The completed bridge can be seen in Fig. 1. It is an extradosed highway bridge with three spans (90 m + 180 m + 90 m). The bridge has a hybrid superstructure with prestressed reinforced concrete flanges and corrugated steel webs. The bridge superstructure is a box cross-section with 3 cells and varying web depth. The bridge erection was started in 2008 and finished in 2011. Despite this girder type often being used in bridges in the last 20 years, there are only a few investigations available in the literature dealing with the fatigue behaviour of these structures.

Fig. 1. Móra Ferenc M43 highway bridge on the Tisza river [2].
