Review

Failure analysis of drill pipe: A review

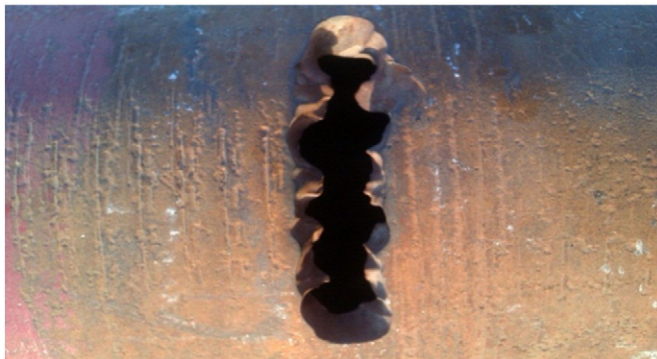
Surface irregularities are macro and micro surface defects on drill pipe body caused by inappropriate handling, incorrect operational use and the most important, slip-cuts. Fig. 1 shows a typical wash-out due to slip-cuts. In the drilling industry, these points are well-known as the fatigue crack initiation sites [1–5]. The effect of dies of gripping systems on fatigue of drill pipe in a deviated well has been studied in several research works by M.K.Rahman et al. [3,4].

Fig. 1. Slip-cuts on 5" DP resulting in a wash-out.
