Engineering Failure Analysis

Partial collapse of the Berlin Congress Hall on May 21st, 1980

R. Helmerich*, A. Zunkel

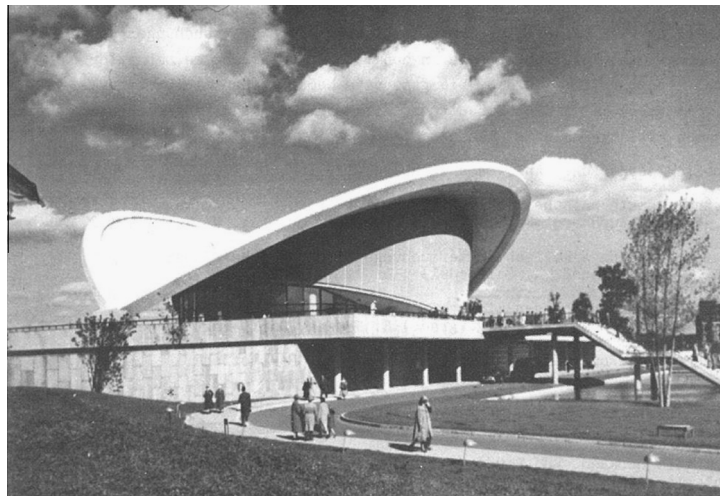
Fig. 1. Original structure of the congress hall before sudden collapse, photograph in 1960 [3].
