## Regular article

## In-situ observation of an irradiation creep deformation mechanism in zirconium alloys

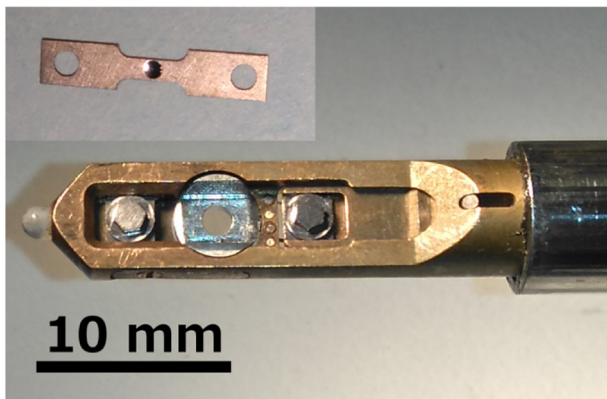
Fig. 1. Head of the heating and straining GATAN TEM sample holder. Encapsulated is shown the dog-bone shape sample used for the in situ straining experiments.

Small tensile test specimens, with electron transparent areas, were taken out of a sheet of a recrystallized zirconium alloy referred to as Zircaloy-4. Details concerning this material and the sample preparation can be found in Supplementary data. The samples were installed on a GATAN single tilt heating and straining holder (Fig. 1). The deformation

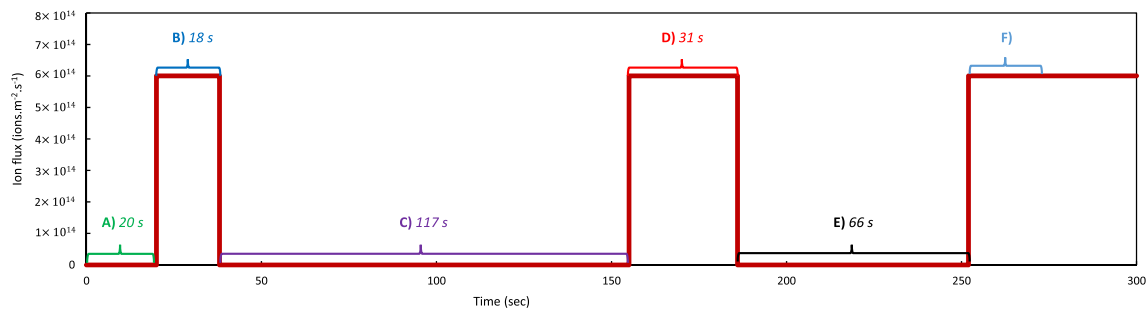
Fig. 2. Irradiation steps during the in-situ irradiation experiment using 1 MeV Kr $^{2+}$  ion at a temperature of 380 °C  $\pm$  30 °C.

To illustrate this phenomenon, one experiment, performed at 380 °C  $\pm$  30 °C, is described and analyzed in the following. The irradiation sequence is explained in Fig. 2 with a plot of the irradiation flux as a function of time. It is composed of irradiation periods, at constant flux of  $6 \times 10^{14}$  ions  $\cdot$  m $^{-2}$   $\cdot$  s $^{-1}$ , noted B, D, F and periods when the ion beam was off noted A, C and E. This sequence was obtained after a short irradiation period of  $0.13 \times 10^{18}$  ions  $\cdot$  m $^{-2}$ . A film showing part of this sequence, accelerated two times, is provided as Supplementary data.
