# An Experimental Investigation on the Dynamic Response of a Damaged Ship with a realistic arrangement of the flooded compartment

In this paper an experimental campaign is conducted on a passenger ferry hull. The effects of obstacles in the engine room compartment, such as decks and engines, on ship roll responses, are studied. Roll decay in still water and steady roll responses in beam regular waves at zero speed are measured for the empty compartment and for the compartment with obstructions, as defined above.

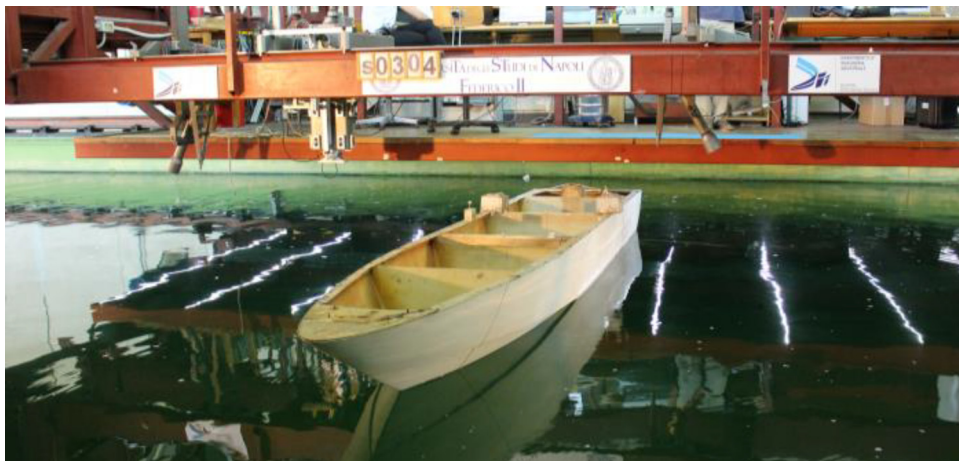
Fig. 1. Model arrangement during the test in beam waves.

The tests are conducted in the towing tank of the Industrial Engineering Department of “Università degli Studi di Napoli, Federico II”. The towing tank is 136 m long, 9 m wide and 4.5 m deep, and it is equipped with an Edinburgh design wave generator. QUALISYS motion capture system is used to measure the motions of the ship model in waves. The six-degree-of-freedom model motions are measured and outputted in real time by gauging the coordinates of infra-red reflective markers, read by suited cameras. Five infra-red reflectors are rigidly placed on the deck of the hull model and the cameras are positioned on the towing carriage near the vessel.
